Moorebank Intermodal Terminal Project Environmental Impact Statement

Technical Paper 5 Environmental Site Assessment (Phase 2)

Client: Moorebank Intermodal Company
Title: Phase 2 Environmental Site Assessment
Subtitle: Moorebank Intermodal Terminal
Document No: 2103829A-CLM-REP-1 RevB
Date: 28 May 2014

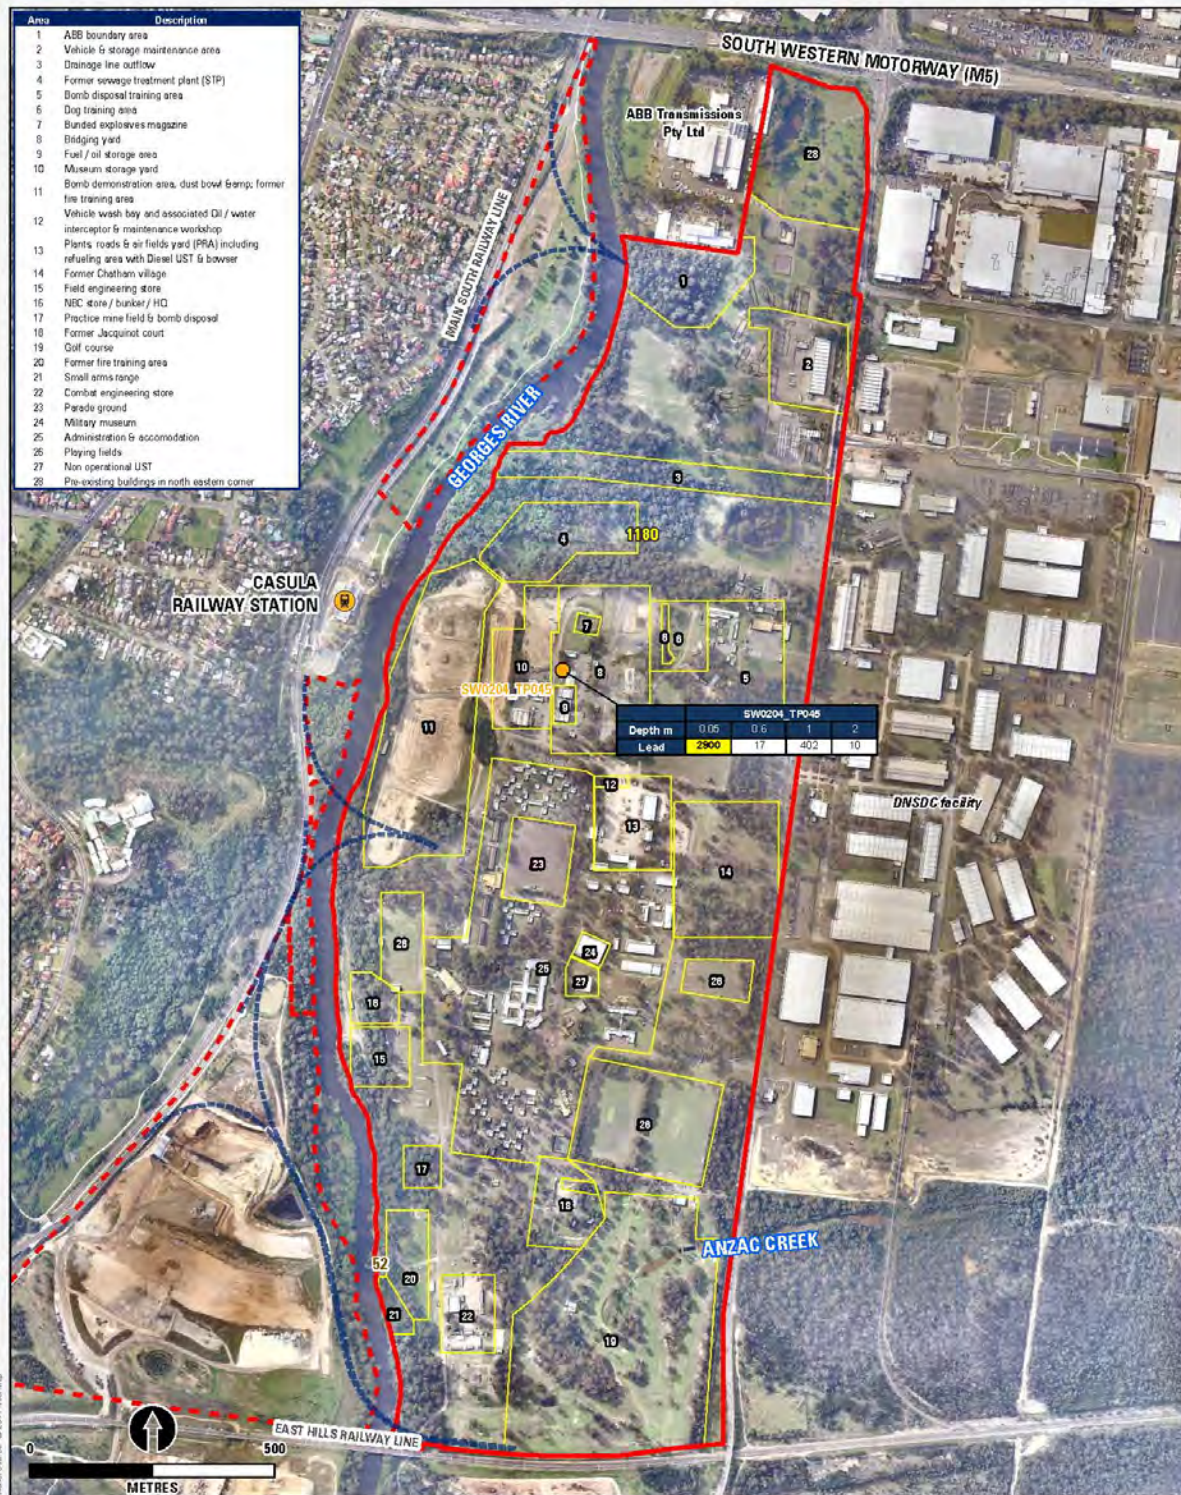
Figure 11: Heavy metals exceeding the adopted health investigation levels

- Moorebank IMT main site
- Land associated with Moorebank
- IMT rail access options
- Footprint of rail corridor associated with the proposed rail access options
- Heavy metals site
- CLM investigation areas
- Rail line
- Structures
- Concentration potentially exceeds relevant soil HSL ⁽¹⁾ and ESL ⁽²⁾ based on sample depth

Notes:
 All Values in mg/kg
 (1) NRPMP (1999) Revised 2012 Schedule B1 Guidelines on Investigation Levels for Soil and Groundwater - Table 1A(1) - High investigation levels for soil contaminants

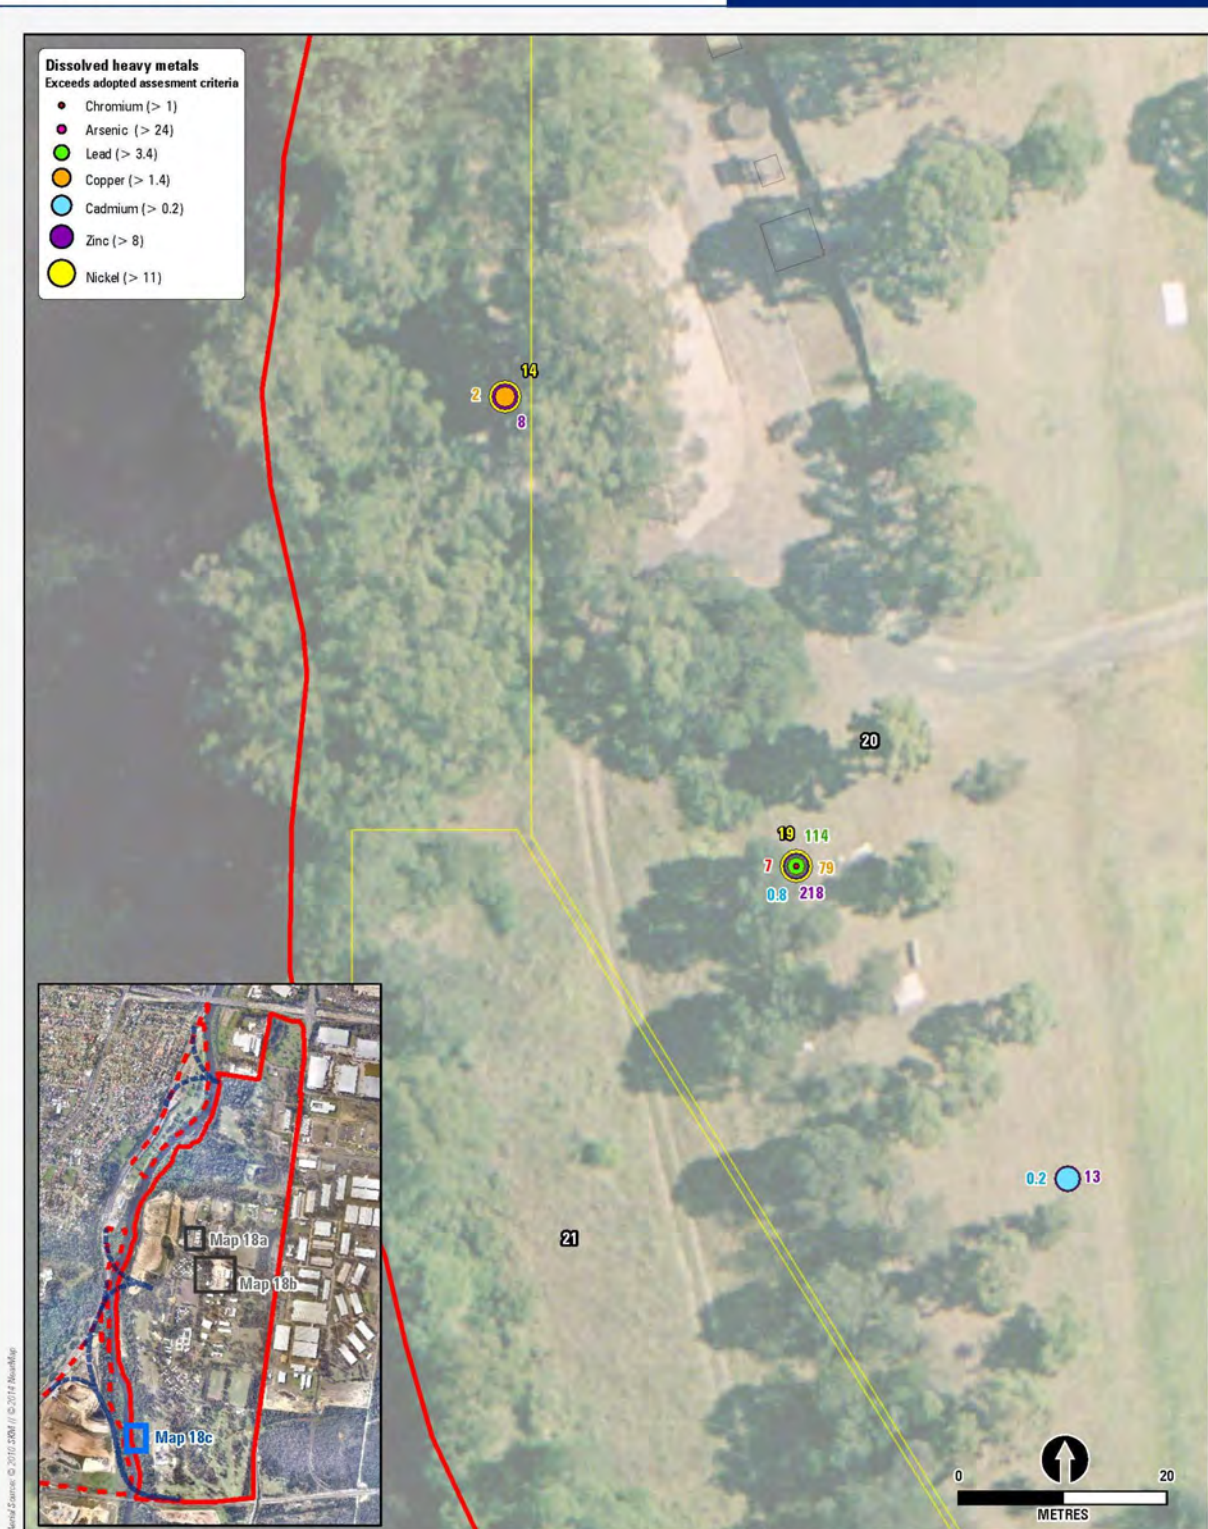
Figure 17c: Dissolved heavy metals in groundwater & surface water

- Moorebank IMT main site
- Land associated with Moorebank
- IMT rail access options
- Footprint of rail corridor associated with the proposed rail access options
- CLM investigation areas
- Structures

Notes:
Criteria based on Australian and New Zealand Guidelines for Fresh and Marine Water Quality (ANZECC/ARMCANZ, 2003) – trigger values for freshwater, 95% level of protection
Mercury results all 0.1 µg/L. These have not been displayed as adopted screening limit from mercury (0.06 µg/L) is above the laboratory detection limit
All Values in µg/L
