Contamination Management plan

Stage 2 Moorebank Precinct East
400 Moorebank Ave Moorebank NSW

Prepared for: Qube Property Management Services Pty Ltd c/o Tactical Group Pty Ltd
EP0716_CMP01 v5 17 April 2018

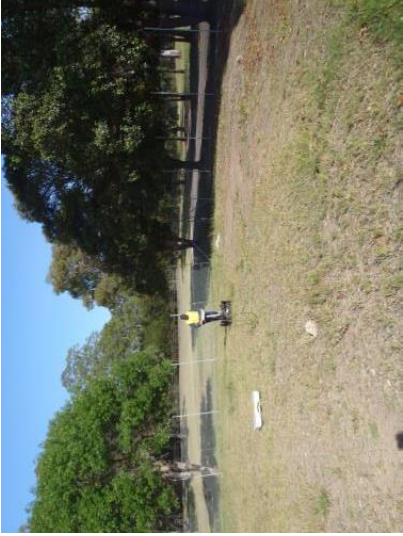
ID	Reported Impacts	Delineation	Uncertainties	Discussion	Validation Sample Analytical Schedule	End Use Criteria to be applied
UST 0367/B_UST _001 (Refer to Figure 4-G)	TRH detected in PB_MW05 between 1.8 to 1.9 m, and 5.8 to 6.0 m depth.	Vertical – no soil TRH impact at 0.2 m or 1.2 m depth. Reduced PID levels recorded from 2.2 to 7.0 m depth. Lateral – no soil impact in PB_MW03 located approximately 20m to the north east during sampling in 2011 (PB, 2014a).	Limited information on lateral delineation. Unknown Materials Stored	Single UST positively identified by GPR survey, est. 3.5m length, 0.5m depth to top of tank. Based on tank length, the estimated volume is 10 kL. The position of the UST during the Golder investigation is shown in the image below.

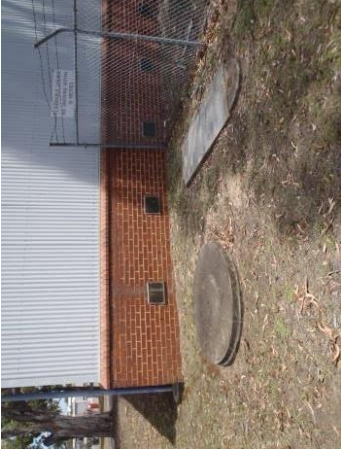
ID	Reported Impacts	Delineation	Uncertainties	Discussion	Validation Sample Analytical Schedule	End Use Criteria to be applied
UST – Waste oil 3767S_UST_003 (Refer to Figure 004-D)	No impacts reported in soil in the Earthtech (2006) investigation locations completed in the vicinity of the UST.	A single in-ground concrete UST and associated in ground concrete triple interceptor trap (TIT). UST was identified adjacent to north eastern corner of Building 17.	An in ground concrete UST and associated TIT was identified during the Golder inspection (November 2014) on the north eastern corner of building 17.	<p>The Golder 2014 inspection identified a UST and TIT at the north eastern corner of Building 16 (refer to image below). This has been inferred as UST_003.</p>

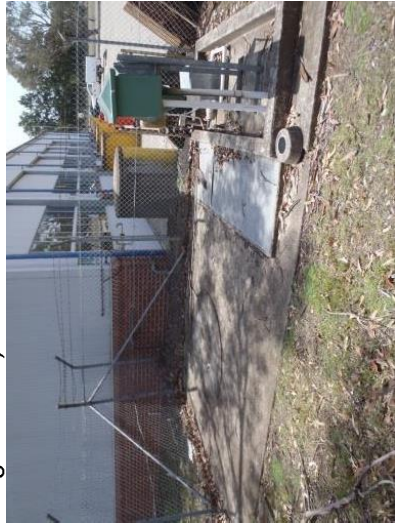
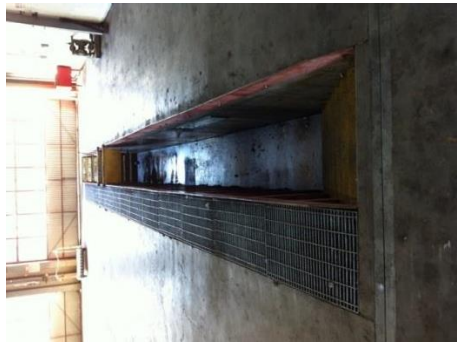
<p>UST – Waste oil 3767S_UST_004, and associated infrastructure (Refer to Figure 004-C)</p>	<p>No impacts reported in soil in the Earthtech (2006) investigation locations completed in the vicinity of the UST.</p>	<p>A single in-ground concrete UST, an associated in-ground concrete TIT and an above ground pump and coalescing plate oil/water separator were observed on the south eastern corner of building 16. An in ground vehicle maintenance trench as observed within building 16.</p>	<p>The Golder 2014 inspection identified a UST and TIT at the north eastern corner of Building 16 (refer to image below). The Golder 2014 inspection identified a drain connecting the Building 16 workshop with the waste oil tank and an inspection trench was observed within Building 16 (refer to images below).</p>

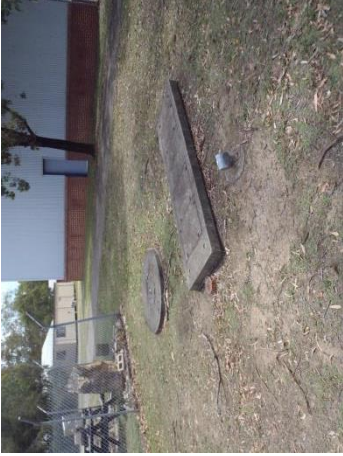
ID	Reported Impacts	Delineation	Uncertainties	Discussion	Validation Sample Analytical Schedule	End Use Criteria to be applied
UST – Waste oil UST_009 Additional UST (Refer to Figure 004-D)	No data currently available on soil and groundwater conditions surrounding the tank.	A single in-ground concrete UST, an associated in-ground concrete TIT were observed in an open grass area approximately 15m east of Building 18.	No data currently available on soil and groundwater conditions surrounding the tank.	<p>The Golder 2014 inspection identified a UST and TIT approximately 15 east of Building 18 (refer to image below). This has been referred to as UST_009.</p>

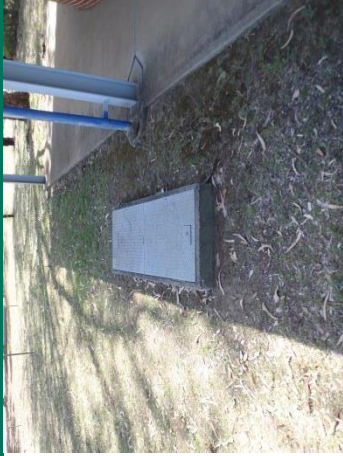
Selected samples for <ul style="list-style-type: none"> Asbestos – if observed PFAS – approx. 25% samples 	
UST – Diesel UST 44467 (Refer to Figure 004-A)	Hydrocarbon impacts were not identified in soil in the immediate vicinity of the tank and fuel infrastructure. Hydrocarbons were detected in soil bore SW0207 completed approximately	A single UST and pipe work associated with the adjacent bowser was confirmed during the GPR investigation. Based on the tank length, the tank volume is estimated at 25 kL.	Limited information on lateral delineation and limited information on soil concentrations in the immediate vicinity of the infrastructure. Low level hydrocarbon impacts in groundwater	The image below shows the area during the Golder 2014 inspection.

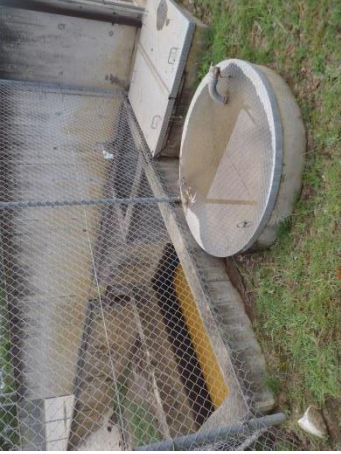
ID	Reported Impacts	Delineation	Uncertainties	Discussion	Validation Sample Analytical Schedule	End Use Criteria to be applied
UST – Waste Oil 03767_UST_010 (Refer to Figure 004-A)	Hydrocarbon impacts were not identified in soil in the immediate vicinity of fuel infrastructure.	A single in-ground concrete UST, with several associated in-ground concrete separator pits were observed on the western side of vehicle wash down bays located at the northern end of the PRA yard.	Limited information on soil concentrations in the immediate vicinity of the infrastructure.	The image below shows the area during the Golder 2014 inspection.

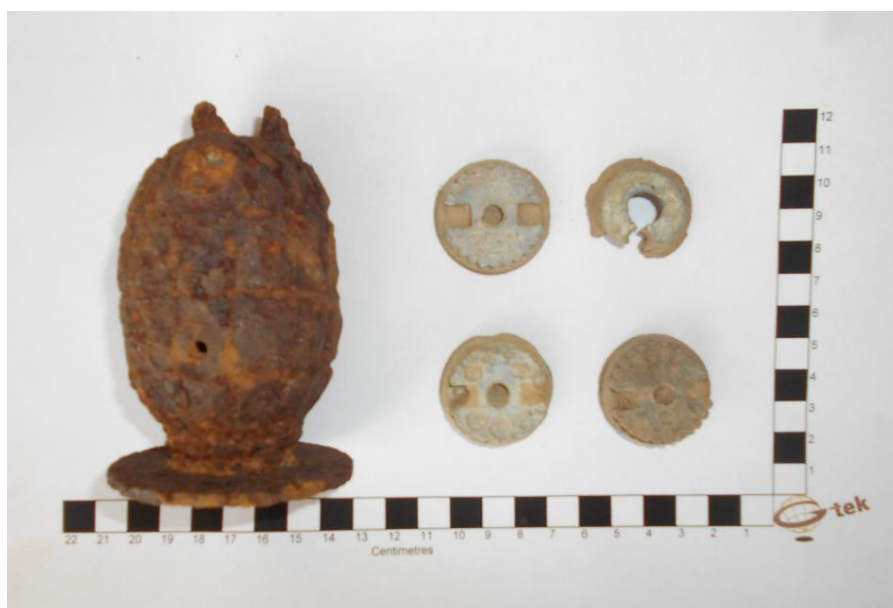
Figure 7 – Grenade Hand 36M and typical 36M EOW

G-tek UXO Safeguarding support to a wide range of intrusive environmental activities within MPE since 2003 have identified no unexploded ordnance (UXO), no explosive ordnance (EO) and no explosive ordnance waste (EOW) within the former DNSDC other than remnant inert hand grenade waste (EOW), within the indicated south-east portion. Remnant inert material is generally grenade base plugs and similar items, all smaller than the UXO remediation parameters used for 2003 remediation works, i.e. “an item half the mass of a 36M Hand Grenade”.

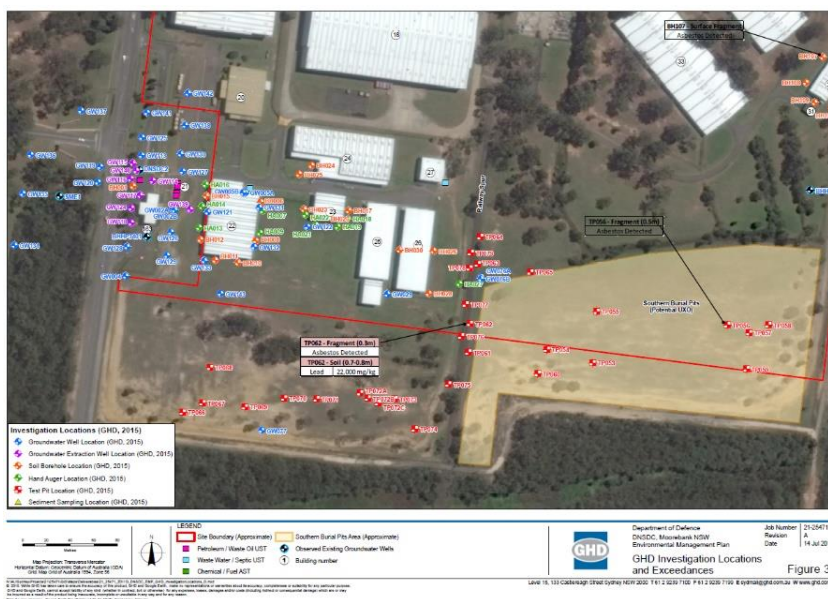
Figure 1 – Southern Burial Pits Area MPE.

G-tek Australia Pty Limited (G-tek) has reviewed previous reports and activities relating to intrusive works within the Moorebank Precinct East (MPE) with particular emphasis on the potential for remnant unexploded ordnance (UXO), explosive ordnance (EO) and explosive ordnance waste (EOW) within the overall Site and the area referred to as the “southern burial pits” in the provided GHD image.

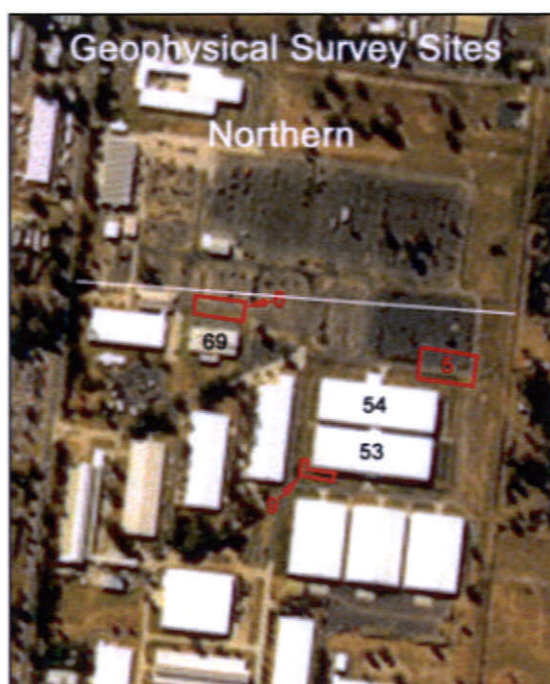
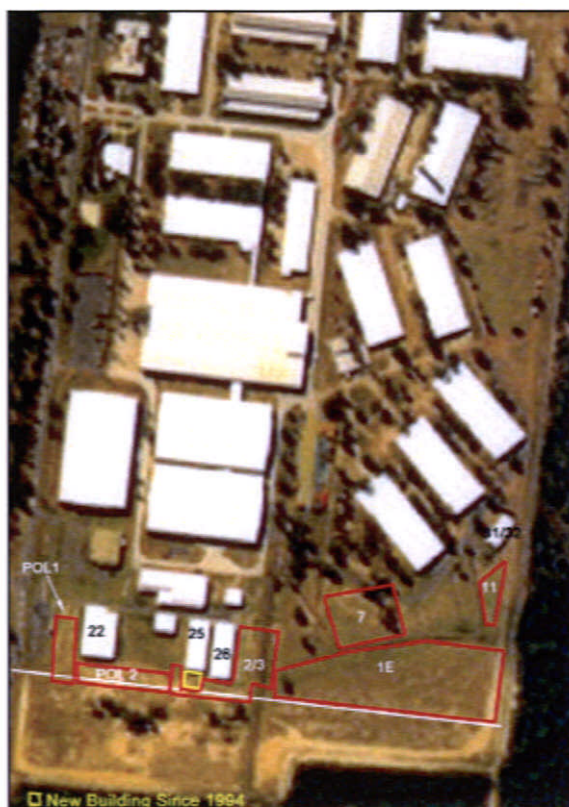
All the site locations, including POL 1/POL 2 are presented on a 1996 aerial photograph of the DNSDC shown below. This photograph shows the approximate positions of the DNSDC precinct boundaries represented by white lines. Building numbers close to the sites are shown in black. The sites shown are not to scale and indicative only of the dimensions and orientation of the geophysical surveys subsequently conducted on these sites.

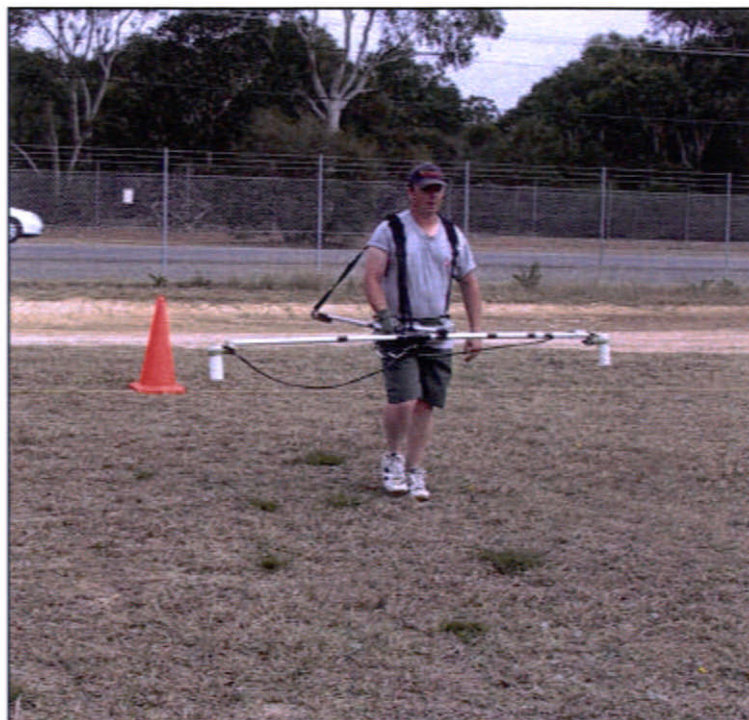
Made by Geometrics Inc. of the USA, the G858 system is in extensive use by the US Army Corps of Engineers and by commercial UXO companies engaged on US Defence site remediation. The unit records all data in the data logger for subsequent down-loading to a PC computer for either on or off-site processing and interpretation. The unit sensors are of high sensitivity and capable of operating at very high sampling rates, making it eminently suitable for the location of buried ordnance.

Geometrics G858 Digital Magnetometer with Dual Sensors at 2m

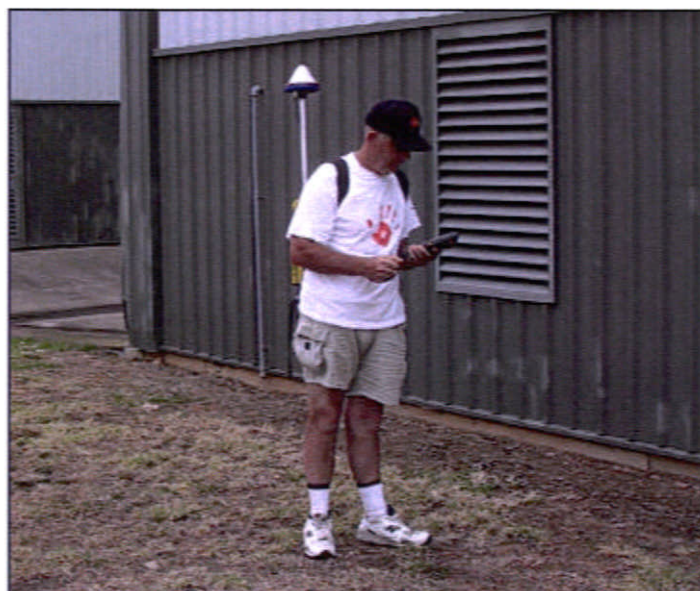
The precise position of external boundaries of each site was first logged with ICOM MAX DGPS, which operates to sub metre accuracy. Sites were grided out using metric chains with walk paths indicated with fluorescent markers.

ICOM MAX DGPS

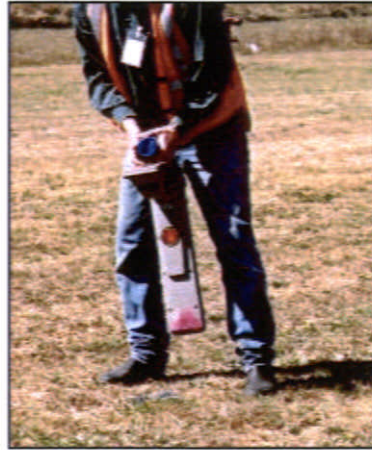
Prior to excavations commencing, a specialist cable locator, Mr. Paul Forbes of Down Under Locaters Pty Ltd, was sub-contracted to locate sites for live cabling and storm water drainage. All such services were identified on the ground by distinct surface markings.

Cable Location in Progress

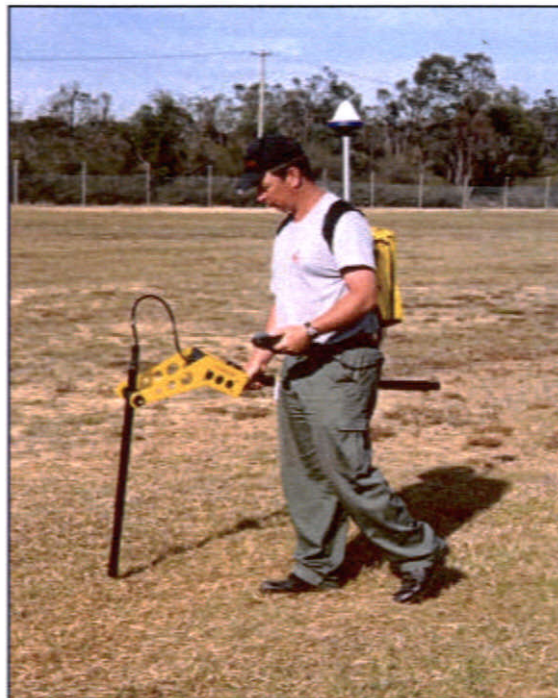
Anomalies for investigation were relocated with the aid of the geophysical survey images which show X and Y coordinates. Positions were either chained out from established grid coordinates or established by DGPS. On arrival at the approximate location, precise positioning was confirmed with an analogue magnetometer.

Re-location of Anomalies Using DGPS and Foerster Magnetometer

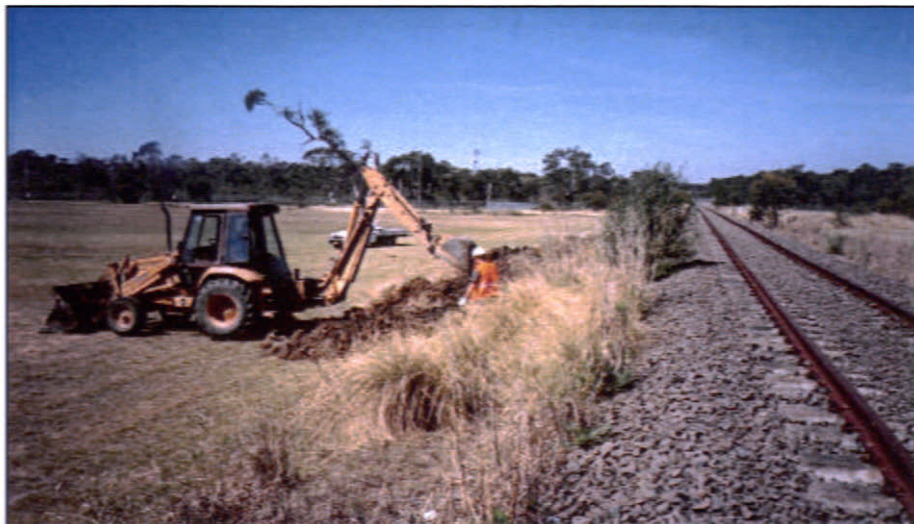
Anomalies were then excavated by mechanical back-hoe working to instructions from the EOD technicians. Mr. Dennis Sencanin of D & G Backhoe Pty Ltd was sub-contracted for this task.

Pit Characterization: Opening of Pit #8 at Site 1E

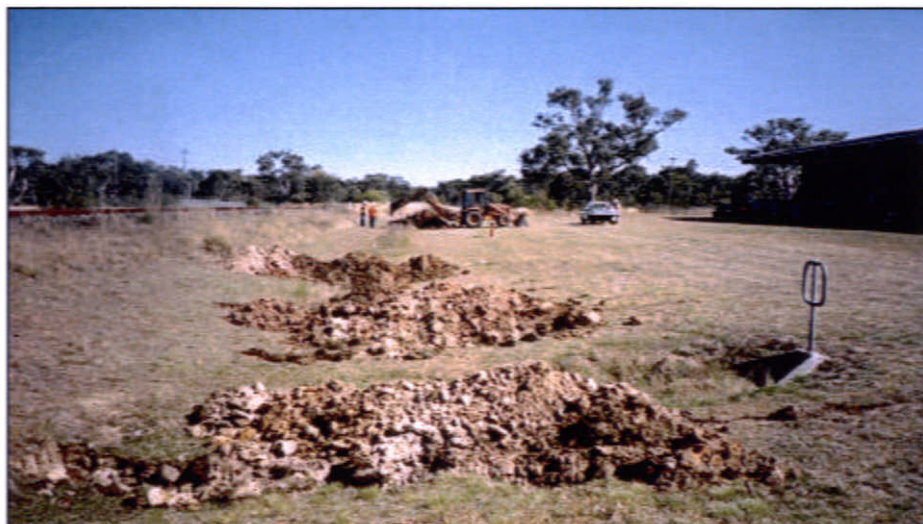
Trenches were dug down to original ground base, to establish a measure of depth for pit capacity estimation. Cross-sectional trenches were dug at regular intervals along the interpreted length of the pit, to ensure that content could be ascertained with reasonable surety and to more precisely gauge the end points and pit width.

Typical Characterizing Trenches: Pit #11, Site 2/3 West of Rail Spur

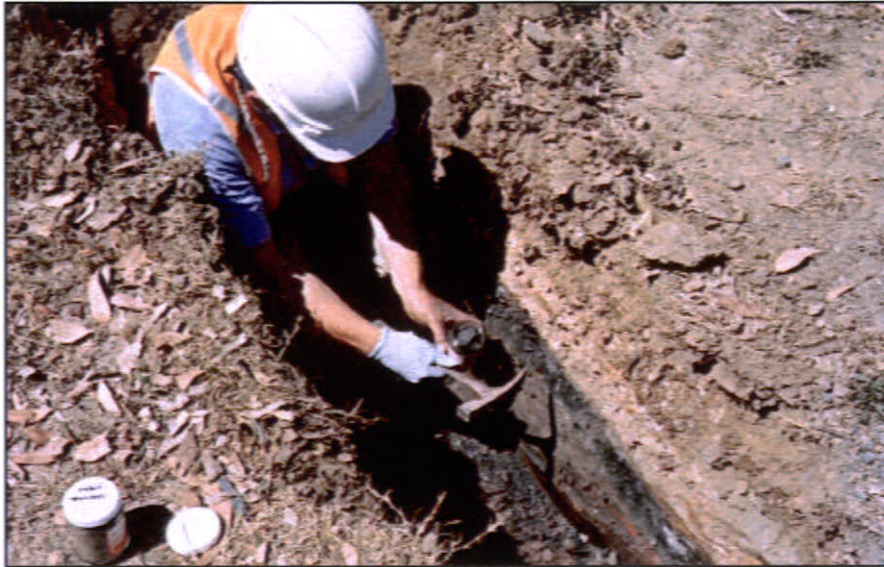
Environmental Representative Taking Soil Samples: Trench in Pit #2, Site 5

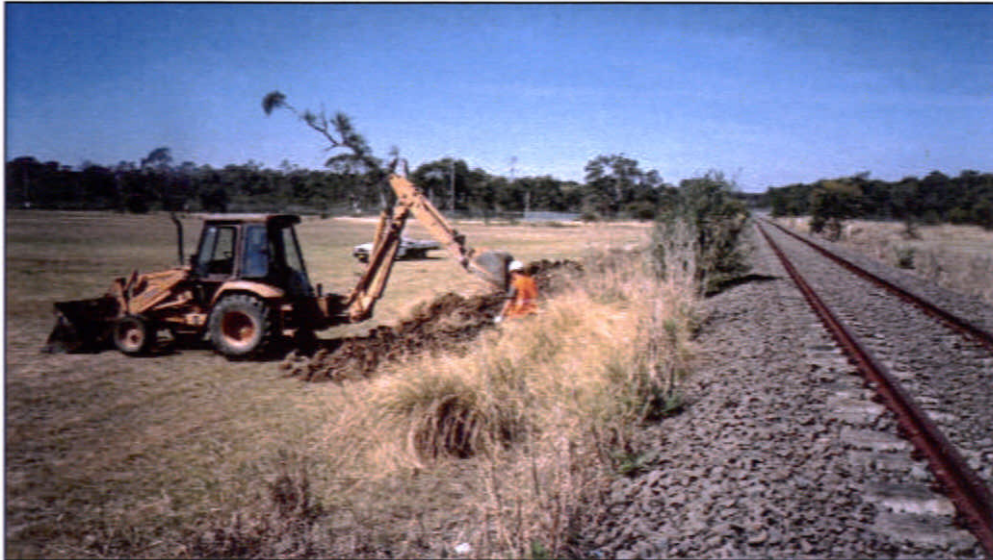
Pit No 8, Site1E: East of the Rail Spur

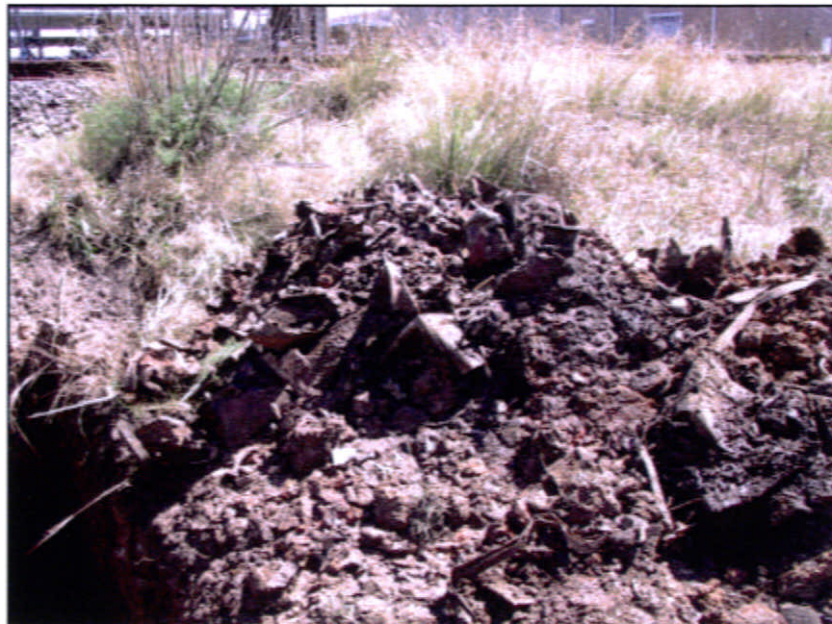
Pit Content, Including Ammunition Boxes : Pit No 8, Site1E

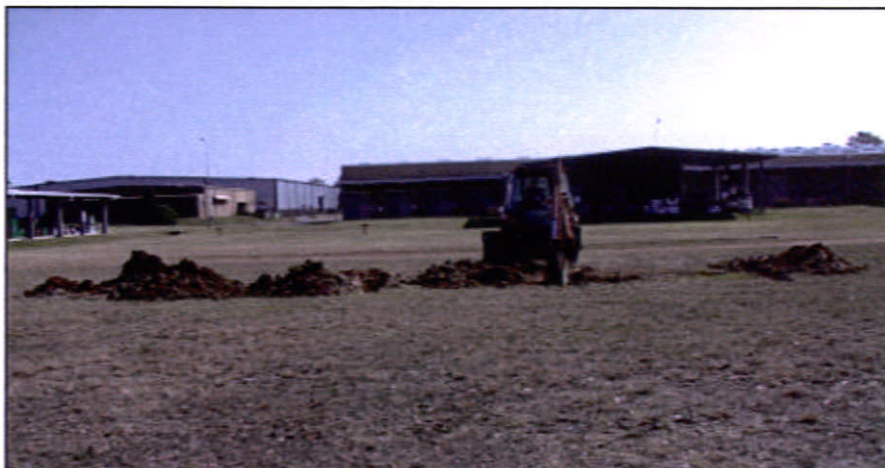
Two pits were investigated in the POL 2 area. Both contained building rubble with large sections of reinforced concrete. The pits were both the same size, being 6m x 3m x 2m deep.

Pits No. 13 and No. 14, Site POL2

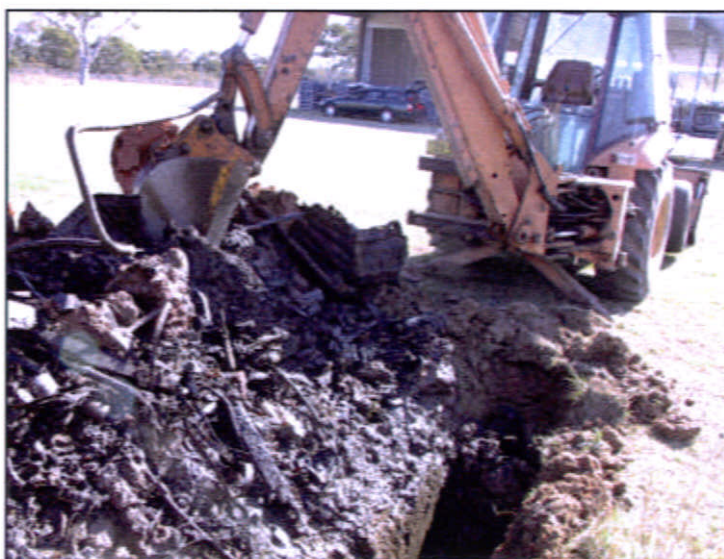
A smaller pit, 6m x 3m x 2m deep, containing building rubbish and a long steel cable, was also excavated on this site.

Pit No 11 at Site 2/3 Close to Rail Spur: Typical Content

Both pits were back filled prior to leaving the site.

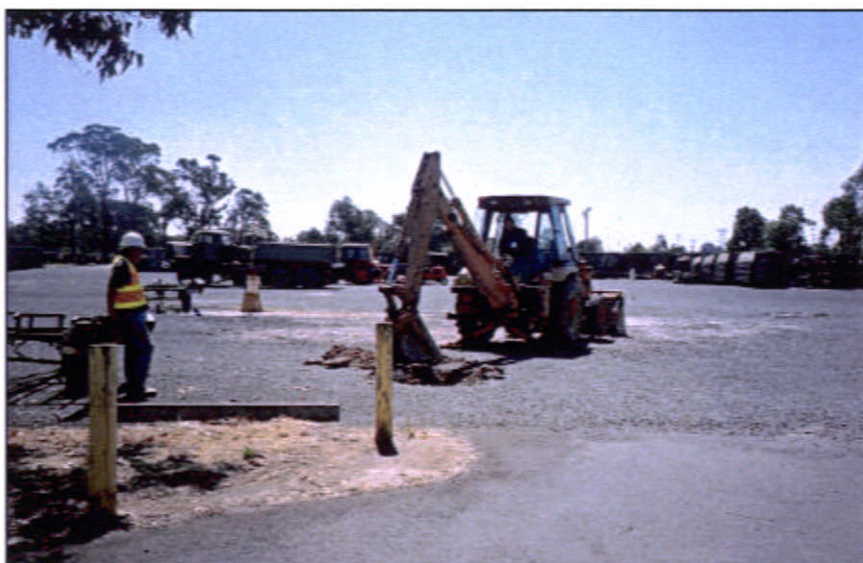
Pit No 1, Site 5. Excavating through Hard-stand

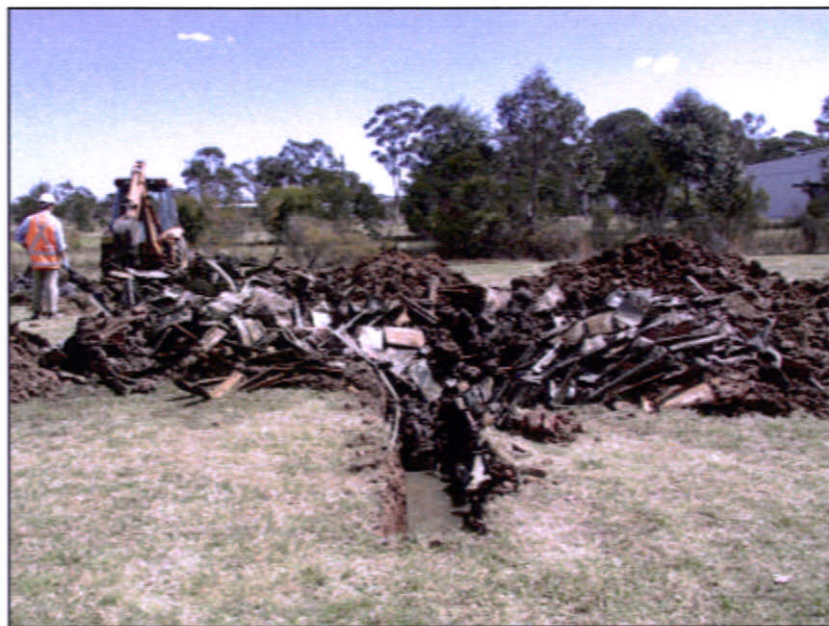
Site 11 was surveyed by G858 and comprised the grassed area south of Building 32. Two large pits No 4 and No 5, each running parallel, were indicated on the geophysical data and intrusive investigation proved this a correct analysis. Pit No 4 closest to the eastern boundary fence, measured 22m x 6m x 4m deep. Pit No 5 to its immediate west, measured 18m x 6m x 4m deep.

Both pits contained large quantities of surplus stores equipment. Items included stores shelving and binning material with a number of long pre-fabricated building tie rods and building material. Both pits contained water trapped in the pit and samples were taken by the environmental consultant for assessment (reported separately). Both pits were backfilled and landscaped on closure.

Pit No 4, Site 11: Metal Shelving and Binning in Contents

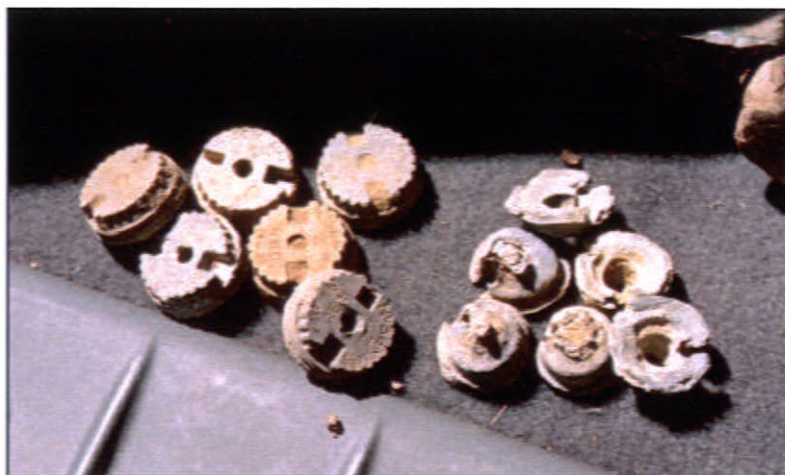
Interviews with Warrant Officers Haz and Edwards of the DNSDC staff, revealed that the grenade material had been trucked onto the site in the late 1970's as part of earthwork training conducted by Plant Wing of the then School of Military Engineering at Casula. WO Haz took part in the earth moving operations. At that time, large quantities of material were taken from the vicinity of the Cities Commission Site controlled by the then NSW Department of Urban and Regional Development (DURD). The Cities Commission was constructing a housing project on the eastern half of the former Anzac Rifle Range. The material taken from that site was accepted to fill swampy ground that previously existed in much of the SE portion of the DNSDC.

36M Grenade Residues: Filling Plugs (L), Fuze wells (R).

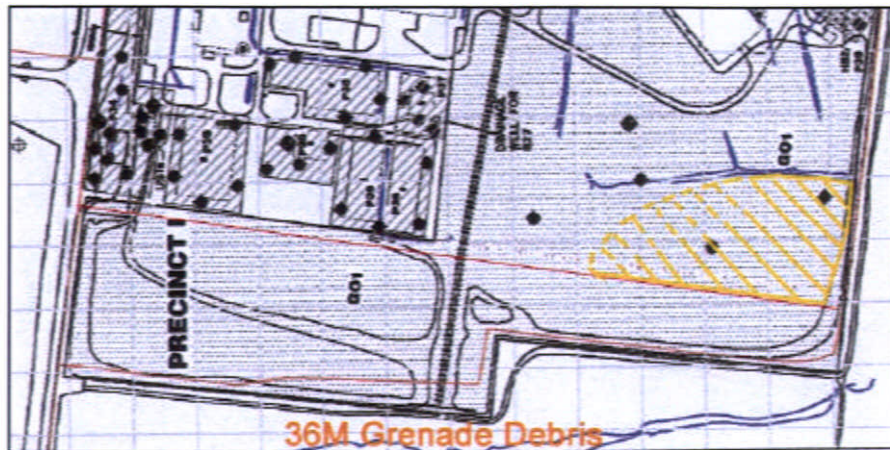
A random detector survey suggests that the main concentrations are as indicated on the attached sketch. There is no evidence that this material is present west of the rail spur line.

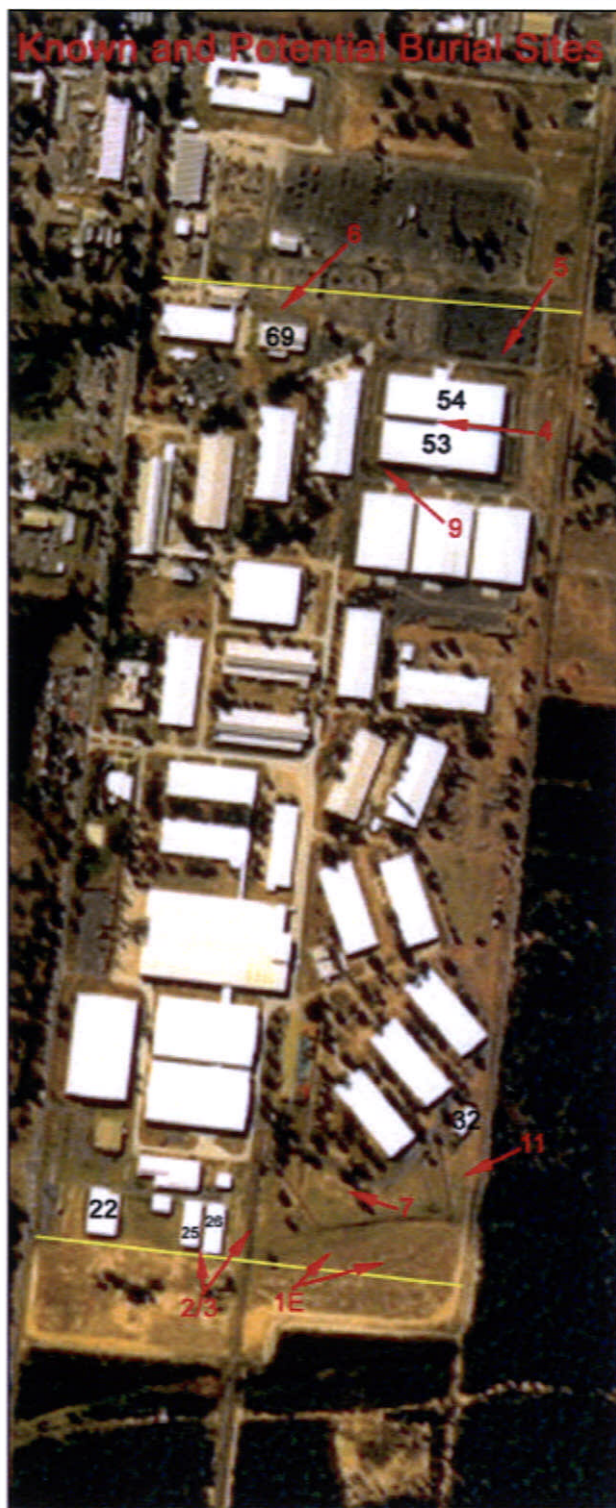
The nine areas of interest are shown below on a composite map of the existing DNSDC area overlaid on a 1970 photograph. A description of each area then follows, with supporting air photography enlargements and other material gathered during the analysis.

**Nine Areas of Known and Potential Burial Pits
(Building Numbers Shown in Black)**

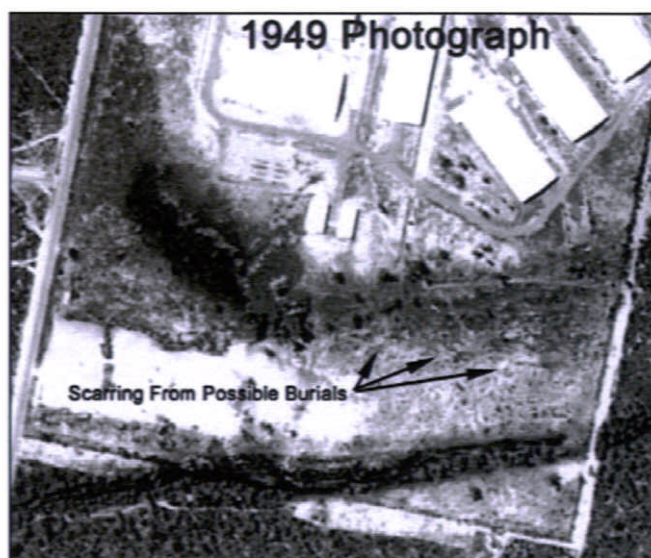
This area is located at the south eastern end of the DNSDC and comprises that land south of the E-W oriented drainage channel. It is surmized that burials were conducted in this area in the period late 1944 through to the early 1950's.

The earliest photography held of the southern portion of the DNSDC was flown in March 1949. This shows what appears to be surface scarring possibly consistent with burial activity. The scarring is more evident in 1955 air photography.

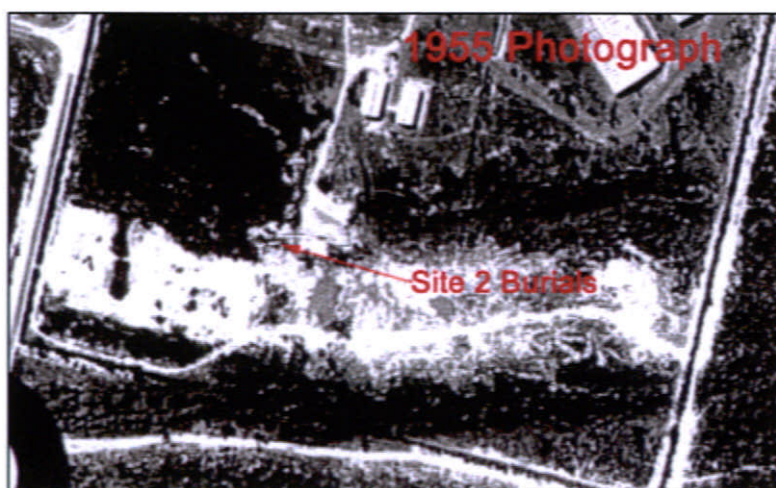
This area is in the south of the DNSDC but immediately north of Site 1 and towards the centre of the Depot. This area was apparently in use at least as early as 1955 and probably until the early 1960's. Two E-W oriented pits can be seen in the 1955 photography, one open and active, the other closed over.

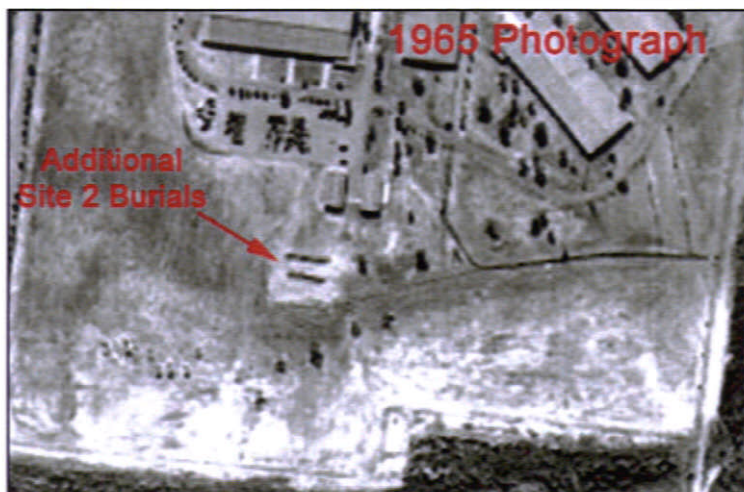
The site continued in use through the 1960's, with a 1965 photograph showing two open E-W oriented pits further to the north of the 1955 pits, with evidence of other parallel pits nearby in closed over condition.

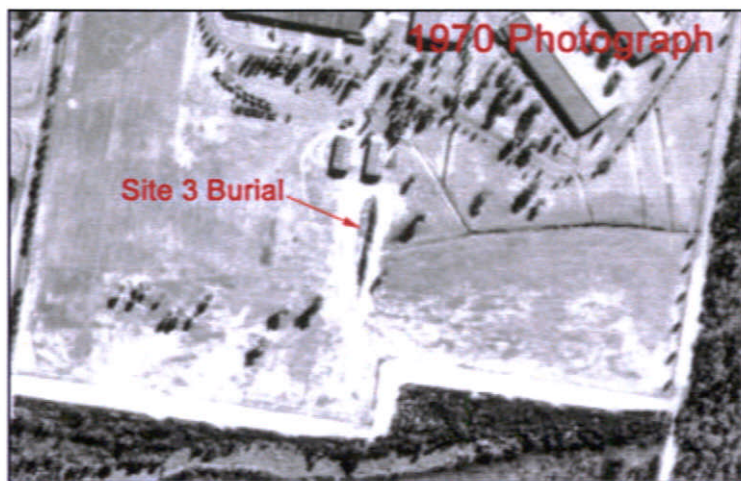
This site is quite close to Site 2, immediately to the north east and near the existing rail spur line. The site appears first in 1970 air photography although probably was in use earlier. This site most likely continued in use into the early 1970s. This site contains a single N-S oriented pit of considerable length. It is located very close to the existing spur line and in the general vicinity of POL building 26.

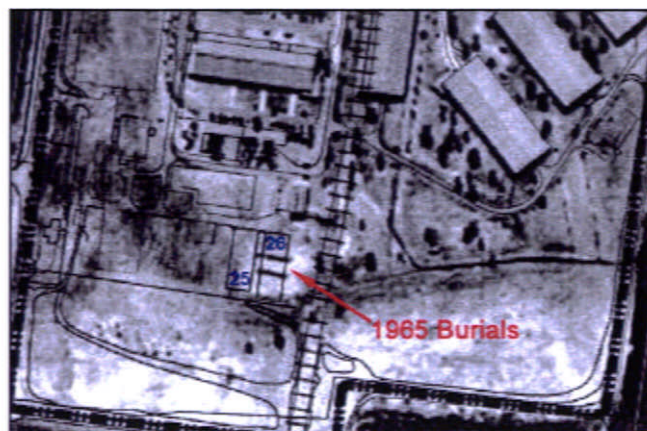
From material held on Milsearch files, the TM-4 surveys were superimposed on the original D.J. Douglas EM31 drawings, which showed the proposed construction footprints of both buildings 25 and 26. From this overlay, a series of short E-W burial trenches existed under the proposed site. These are now assumed to be the pits described at Site 2. An examination of a composite plan of existing structures overlaid on the 1965 photography confirms this.

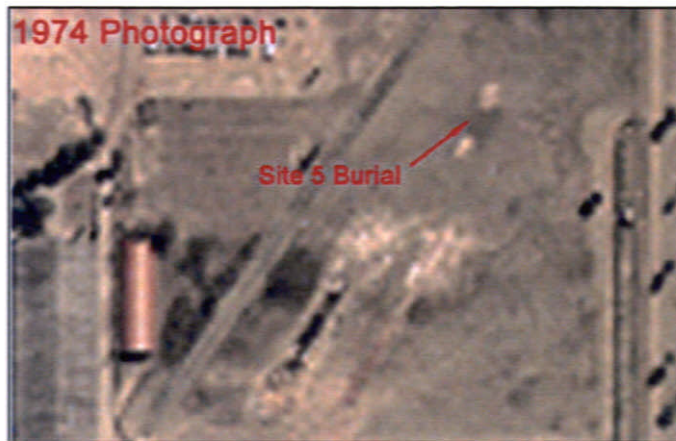
This site is to the north east of Site 4 and appears in the same 1974 photography. A single burial trench of smaller proportions is sited parallel to the rail spur oriented NE-SW. This pit is closed over in the 1994 photography and is not apparent in earlier photography, indicating its period of operation was quite limited. It is located sufficiently north to be outside the footprints of the new facilities. It is probable that its presence was not located during the 1994 remediations and that this pit still remains beneath vehicle hard-stand north east of the new building.

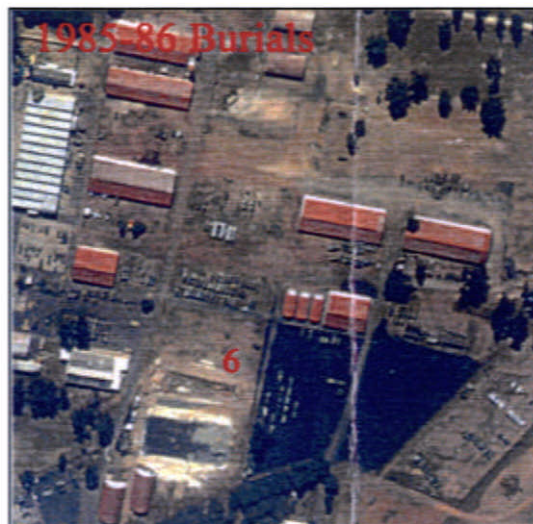
This area is immediately north of the Communications-Electrical Stores Workshop Building 69 in the north west of the DNSDC. An active excavation appears first in 1985 photography and again in the 1986 photography. It is a large excavation of unknown purpose, and does not seem to be typical of a bull-dozed pit.

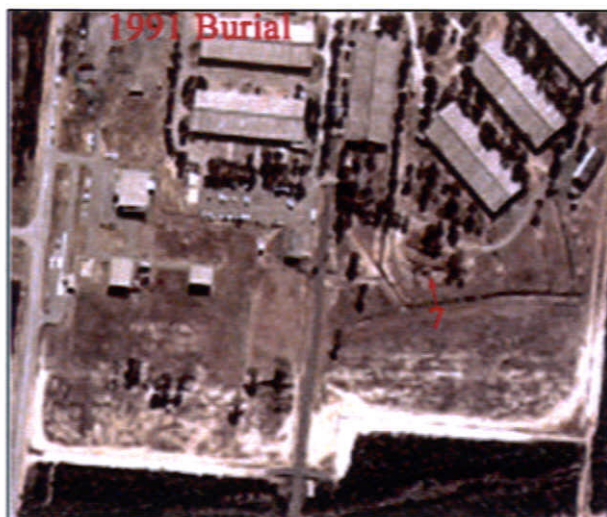
This area is in the southern portion of the DNSDC, east of the rail spur line and close to the warehouses. Ground scarring consistent with burial activity appears in the 1991 photography, with one, perhaps two E-W oriented pits being evident close to mature trees. The pits appear closed over with the site inactive in 1994 photography.

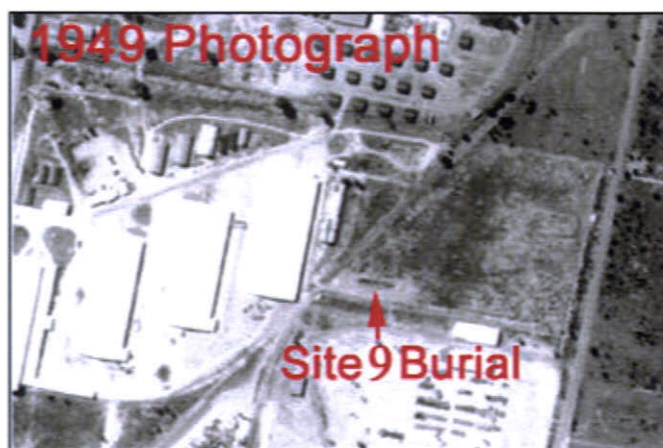
A composite overlay of the existing facilities over a 1955 air photograph was also examined. This suggested that the single E-W pit was probably now under the extreme southern edge of Building 53. If another 'sister' pit existed to the south, then that would be outside the existing Building 53.

Given the possibility that another burial may exist here, a geophysical survey of a limited zone close to the south west corner of Building 53 appears warranted.

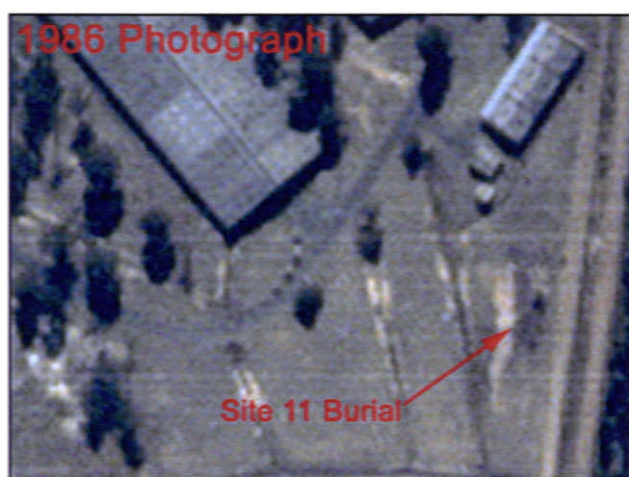
This area is in the south east of the DNSDC, immediately south of the former radiation hazard buildings 31 and 32. Indications of a closed over burial pit oriented N-S appear first in 1986 photography. These indications are also visible in 1991 photography. The area is about 1 hectare in size and is bounded by a drainage channel to the west.
