# Construction Flora and Fauna Management Plan

Moorebank Precinct East Stage 1 – RALP No. 1

<b>Project number:</b>	N01031
<b>Document number:</b>	EN-PLN-0017
<b>Revision date:</b>	21 May 2019
<b>Revision:</b>	07

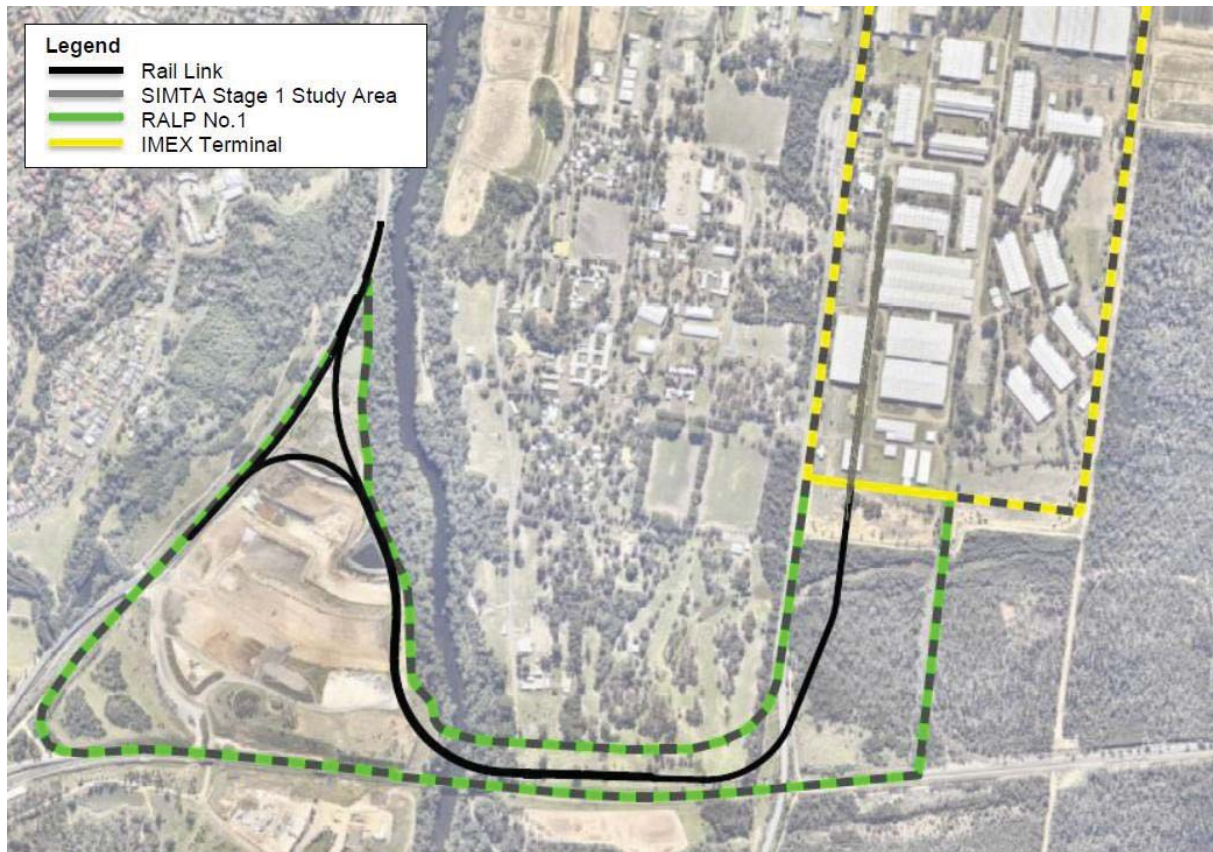
Figure 1: Indicative Project Map

An indicative map of the Project is provided in Figure 1 below.

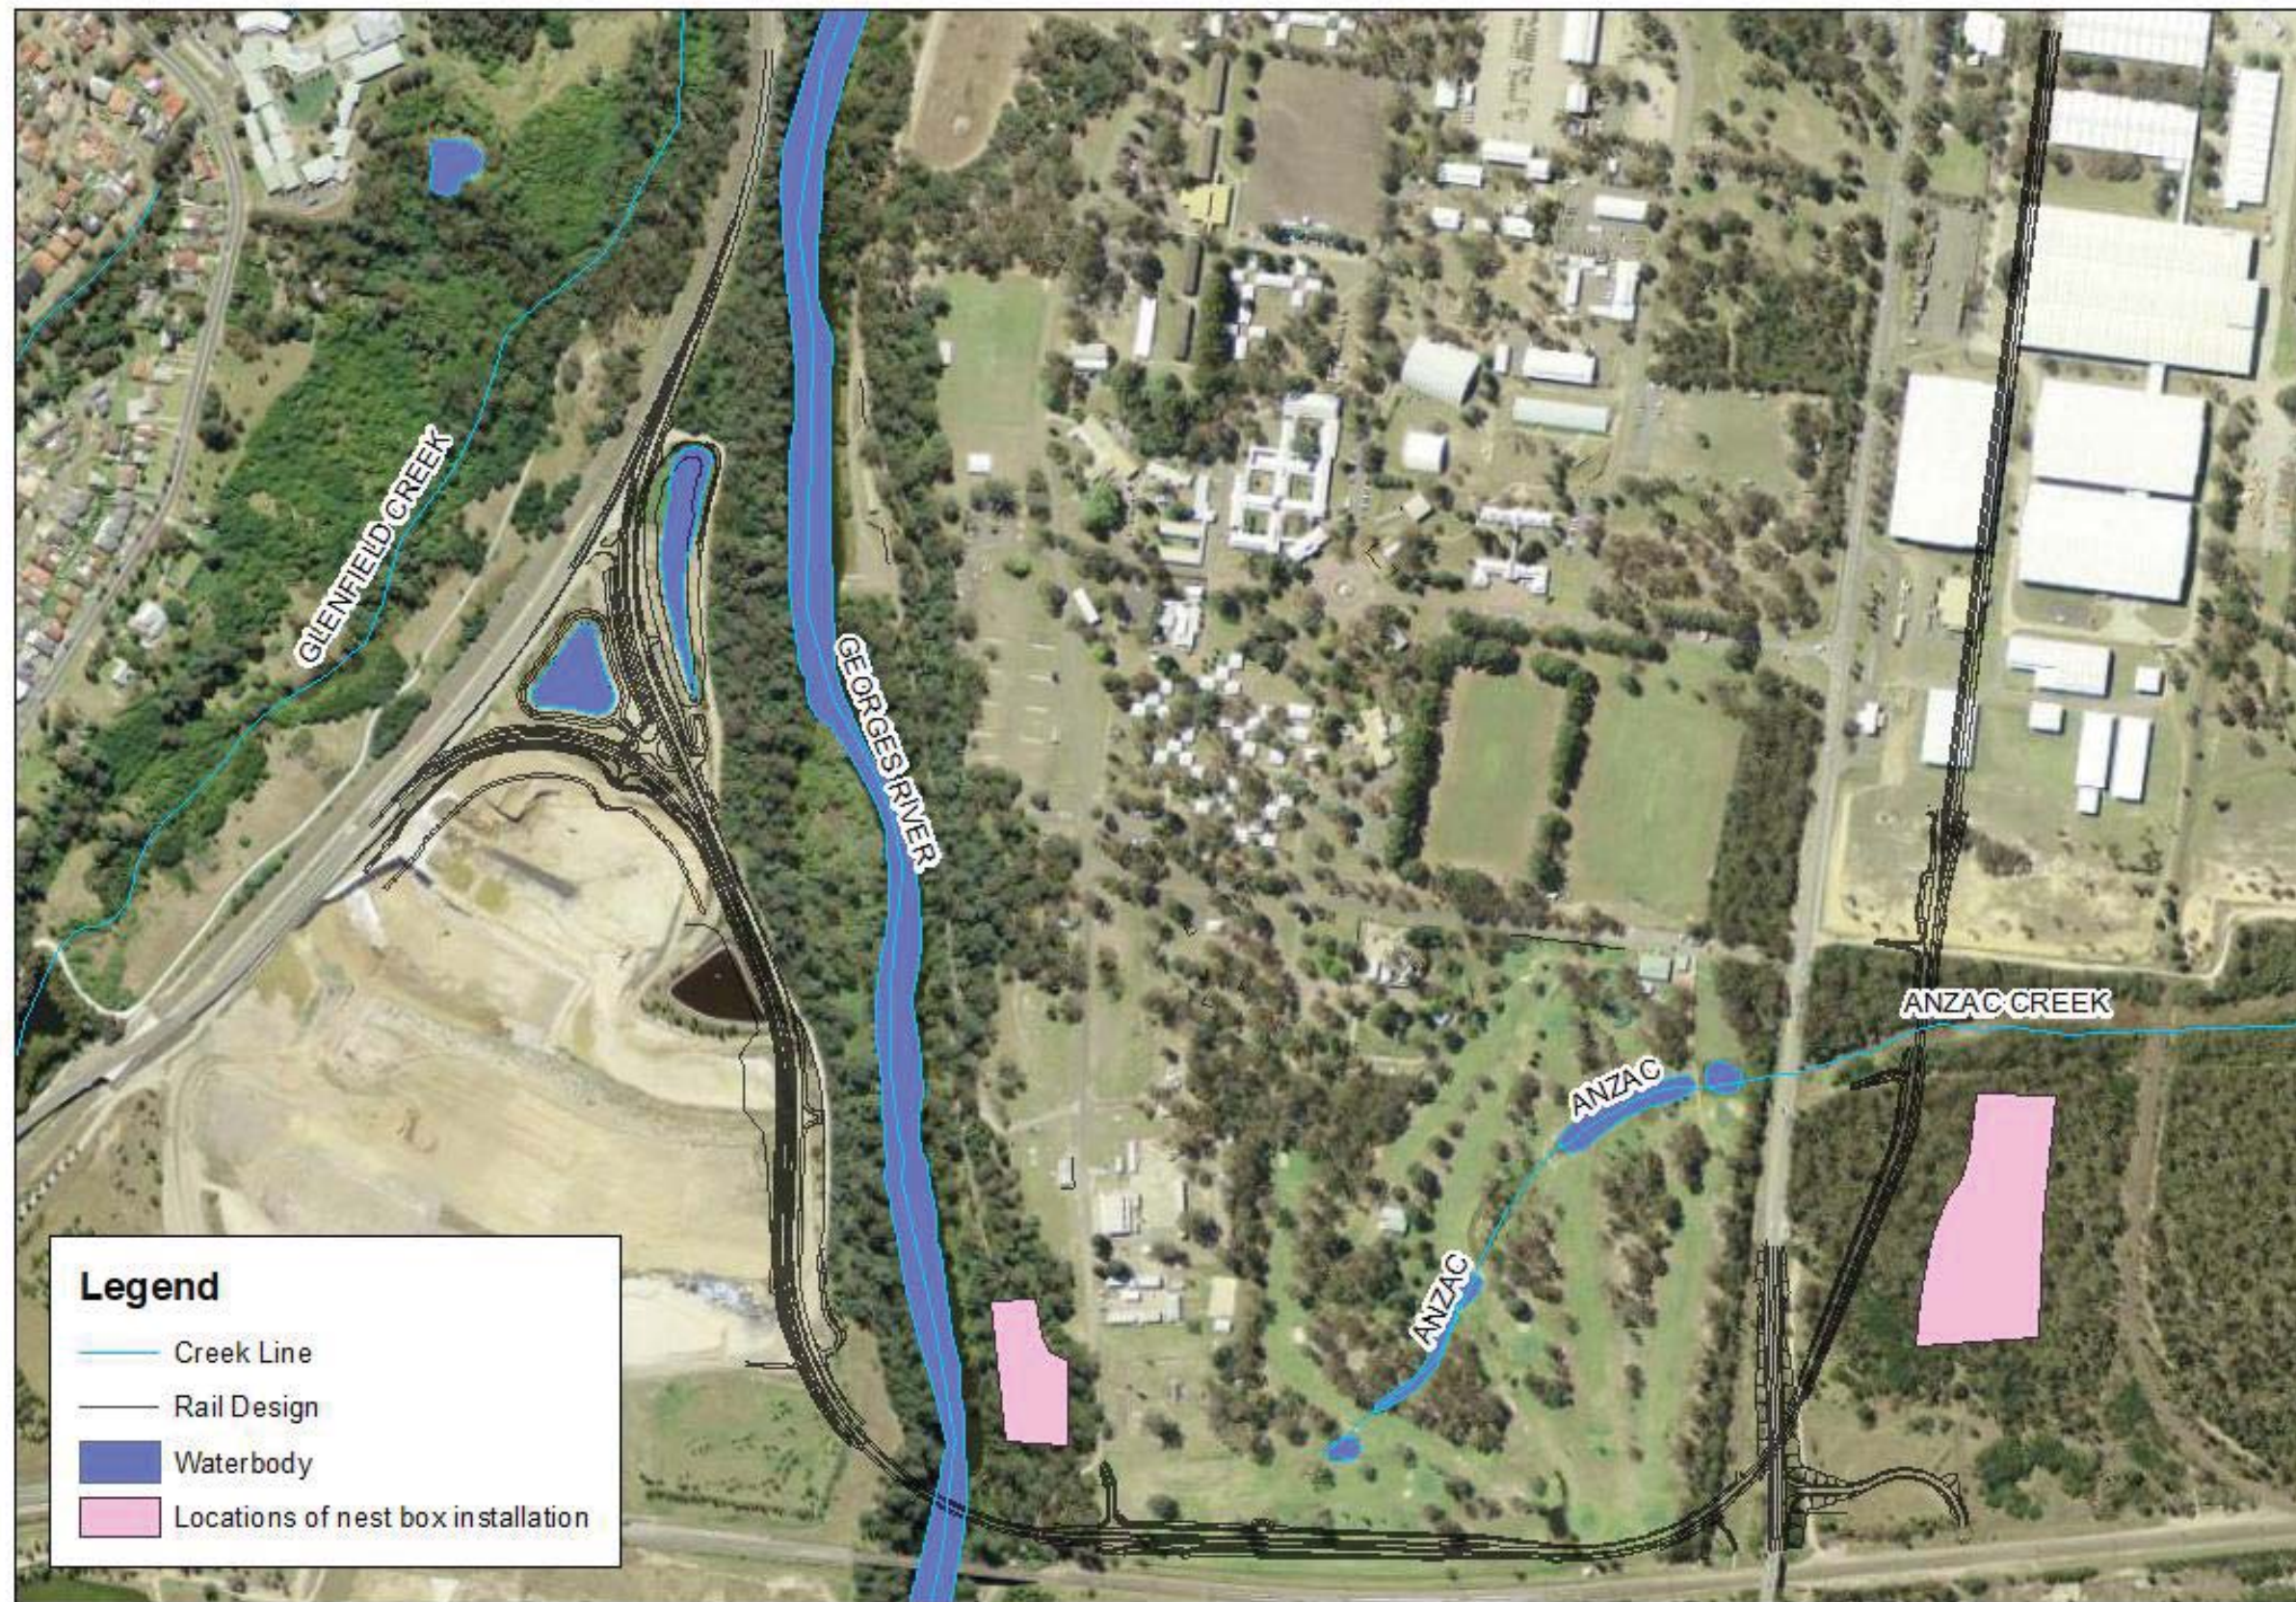
Nest boxes to replace the three hollow bearing trees identified in field surveys from the EIS will be installed up to one month prior to the commencement of clearing activities in order to provide refuge habitat for fauna that may be displaced during clearing. This will include the six nest boxes that are required to compensate the loss of the three tree hollows identified within the Rail Link project.

Figure 4: Potential Locations for Nest Box Installation

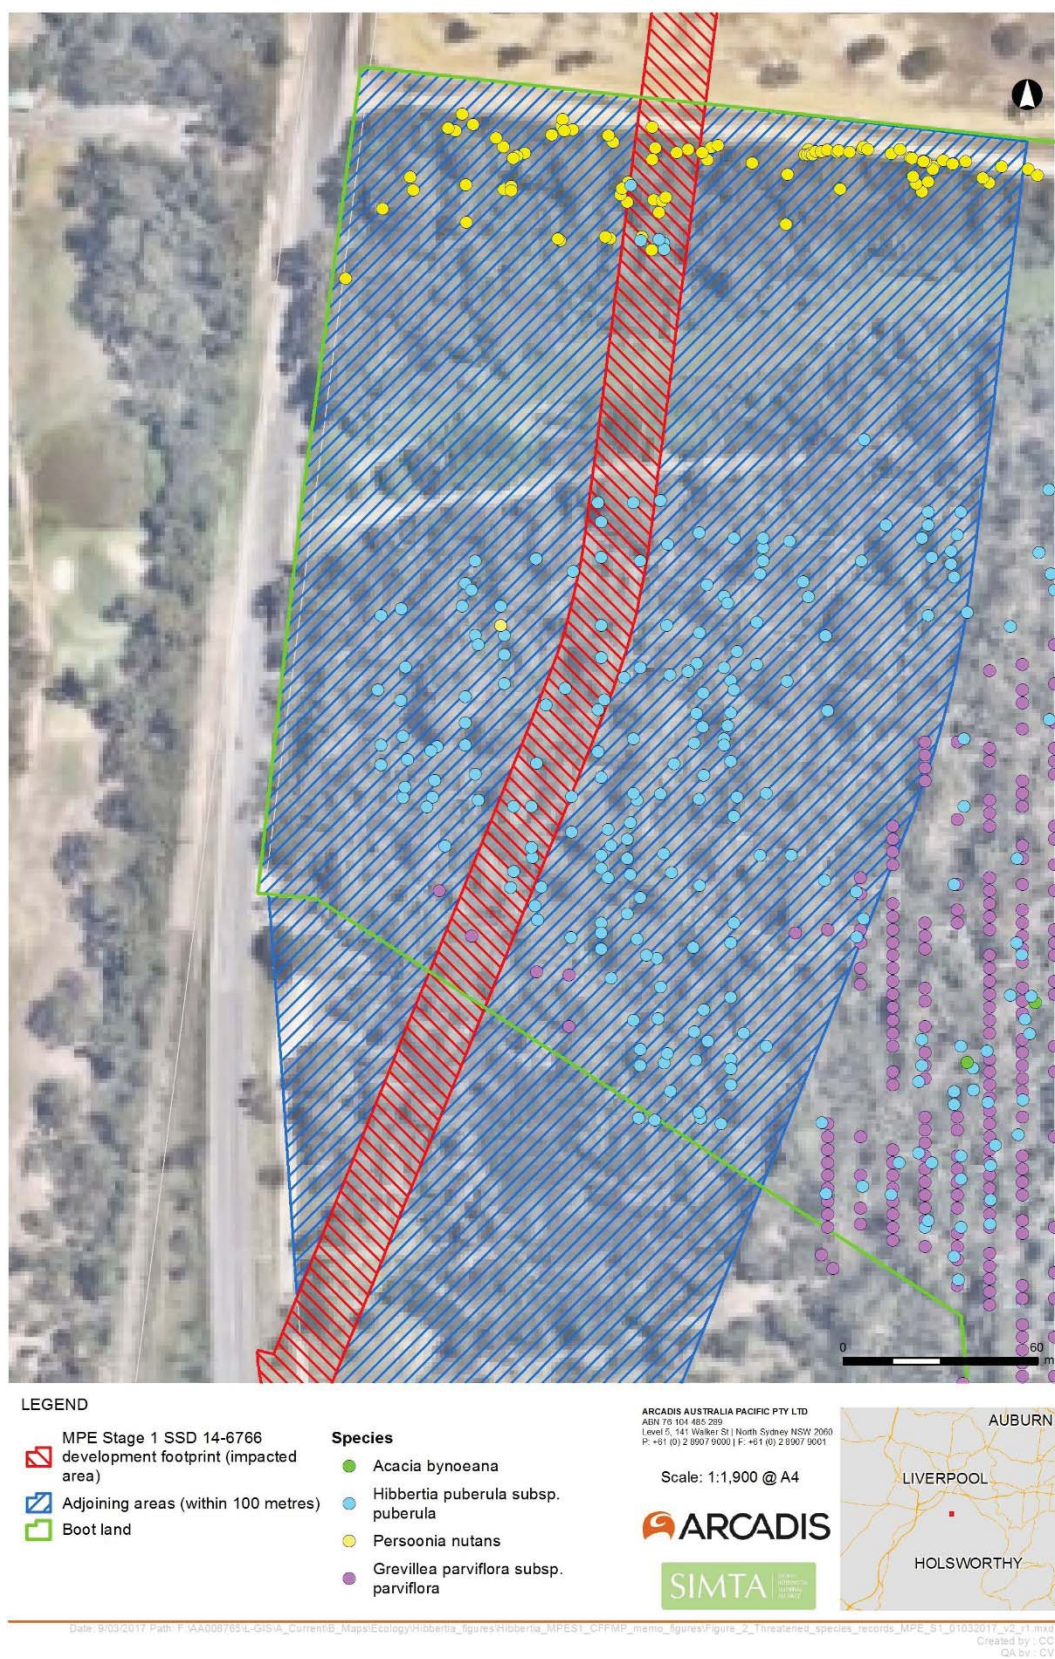
Figure 2. Locations of threatened plant species recorded in October-November 2016 and February 2017 in relation to the MPE Stage 1 Rail link

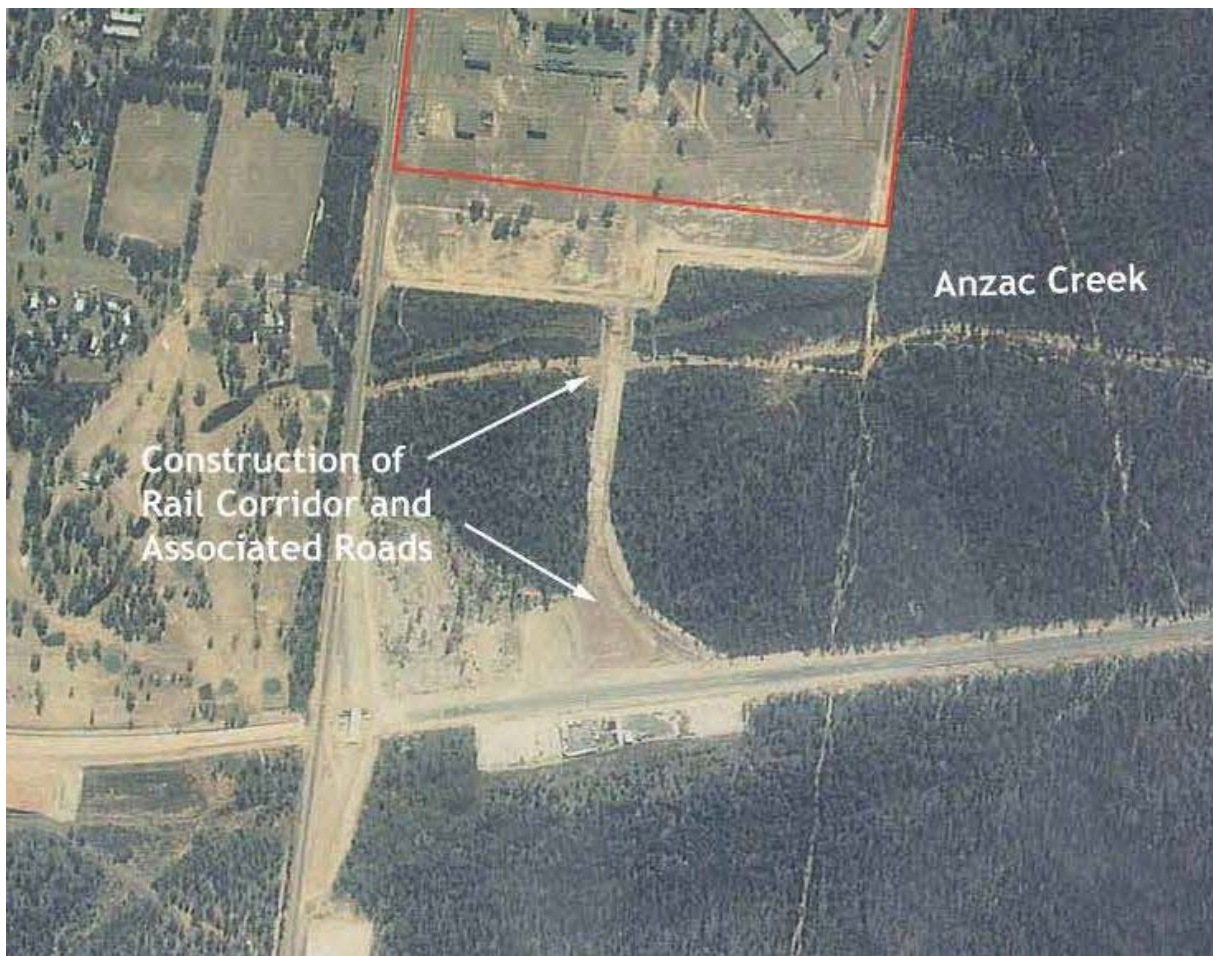
*Figure 3. 1986 aerial photograph showing clearing associated with construction of existing Defence rail spur and East Hills rail corridor. Extract from Figure A6 of AHMS (2012) Aboriginal Cultural Heritage Assessment prepared for SIMTA Part 3A Concept application.*

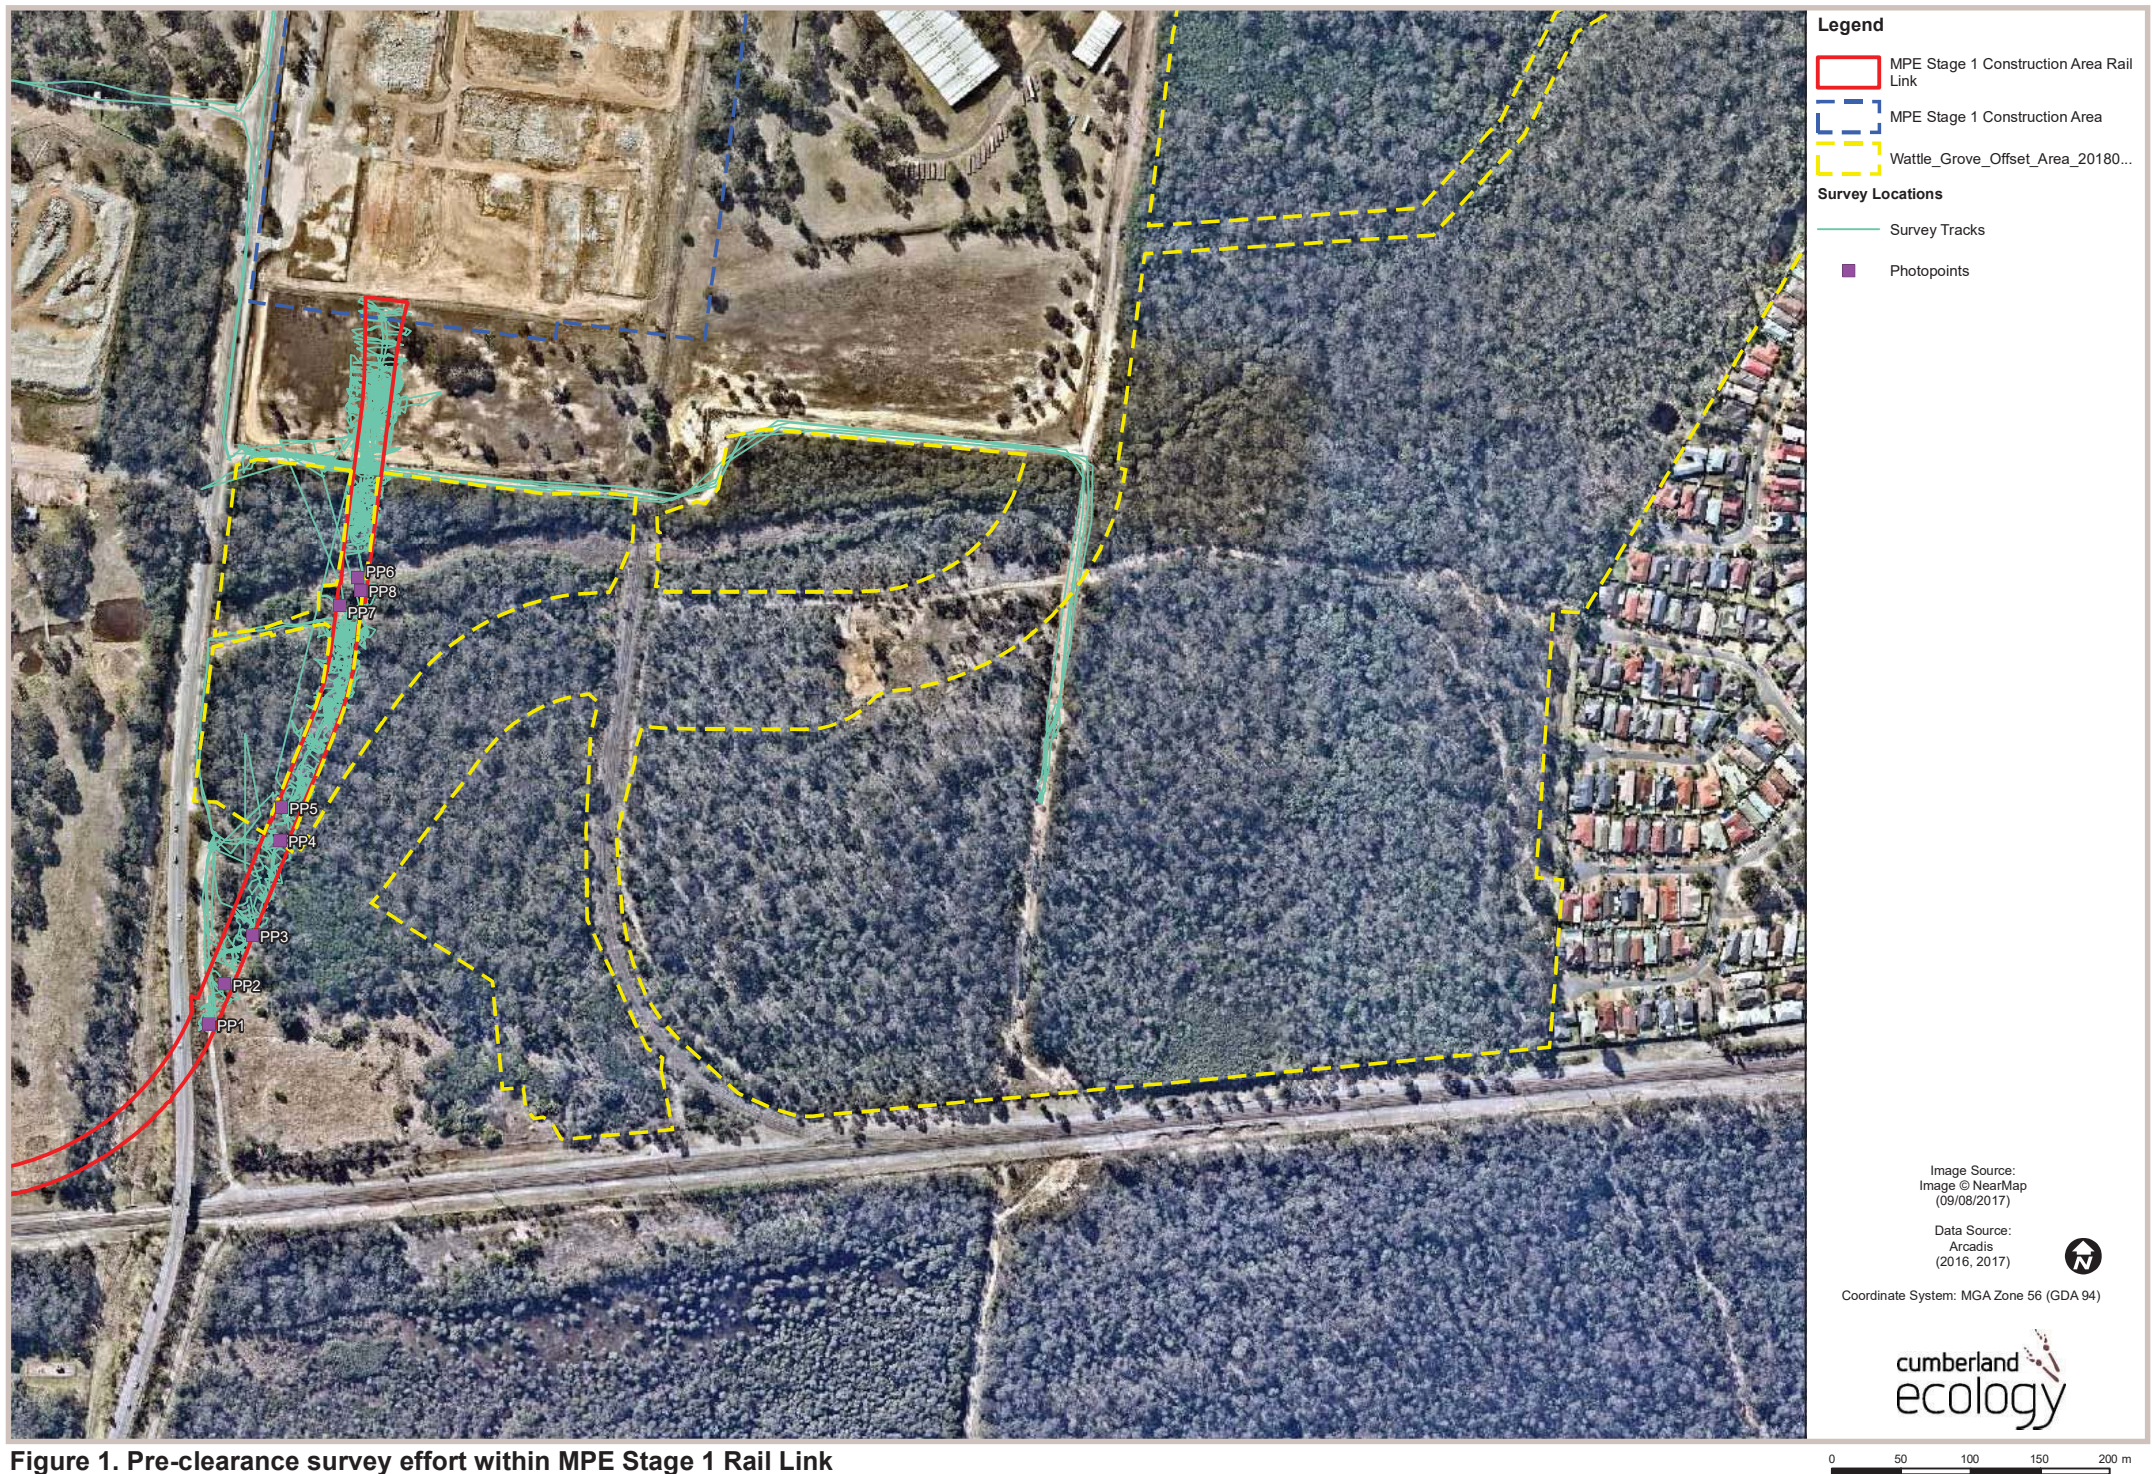
Figure 1. Pre-clearance survey effort within MPE Stage 1 Rail Link

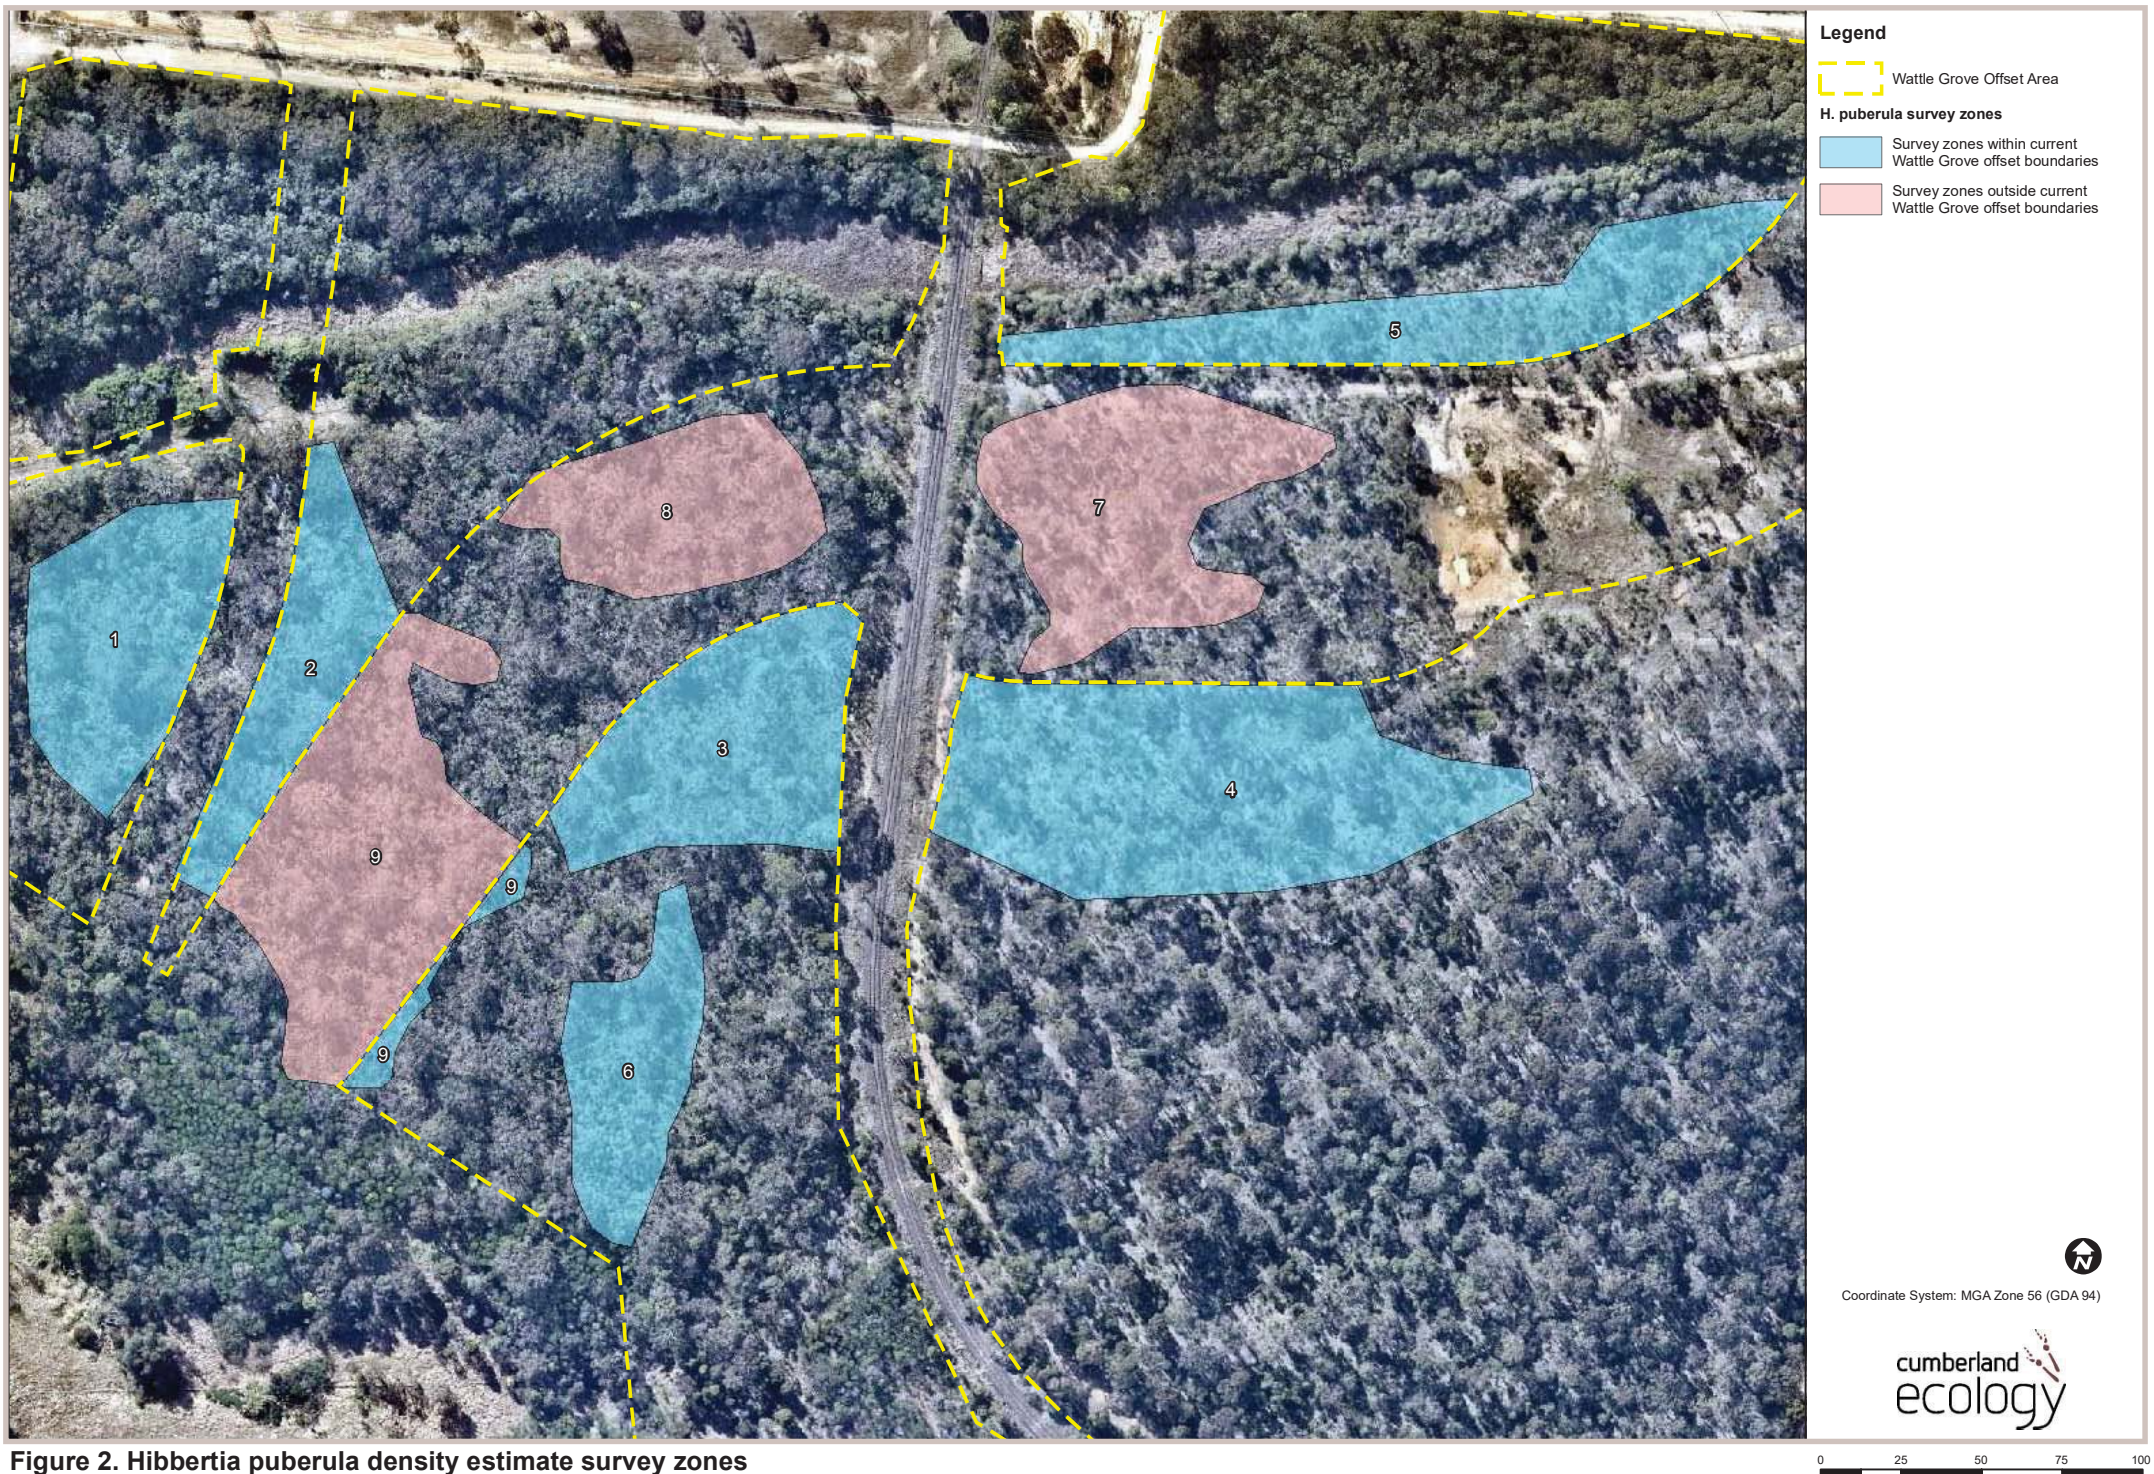
Figure 2. *Hibbertia puberula* density estimate survey zones

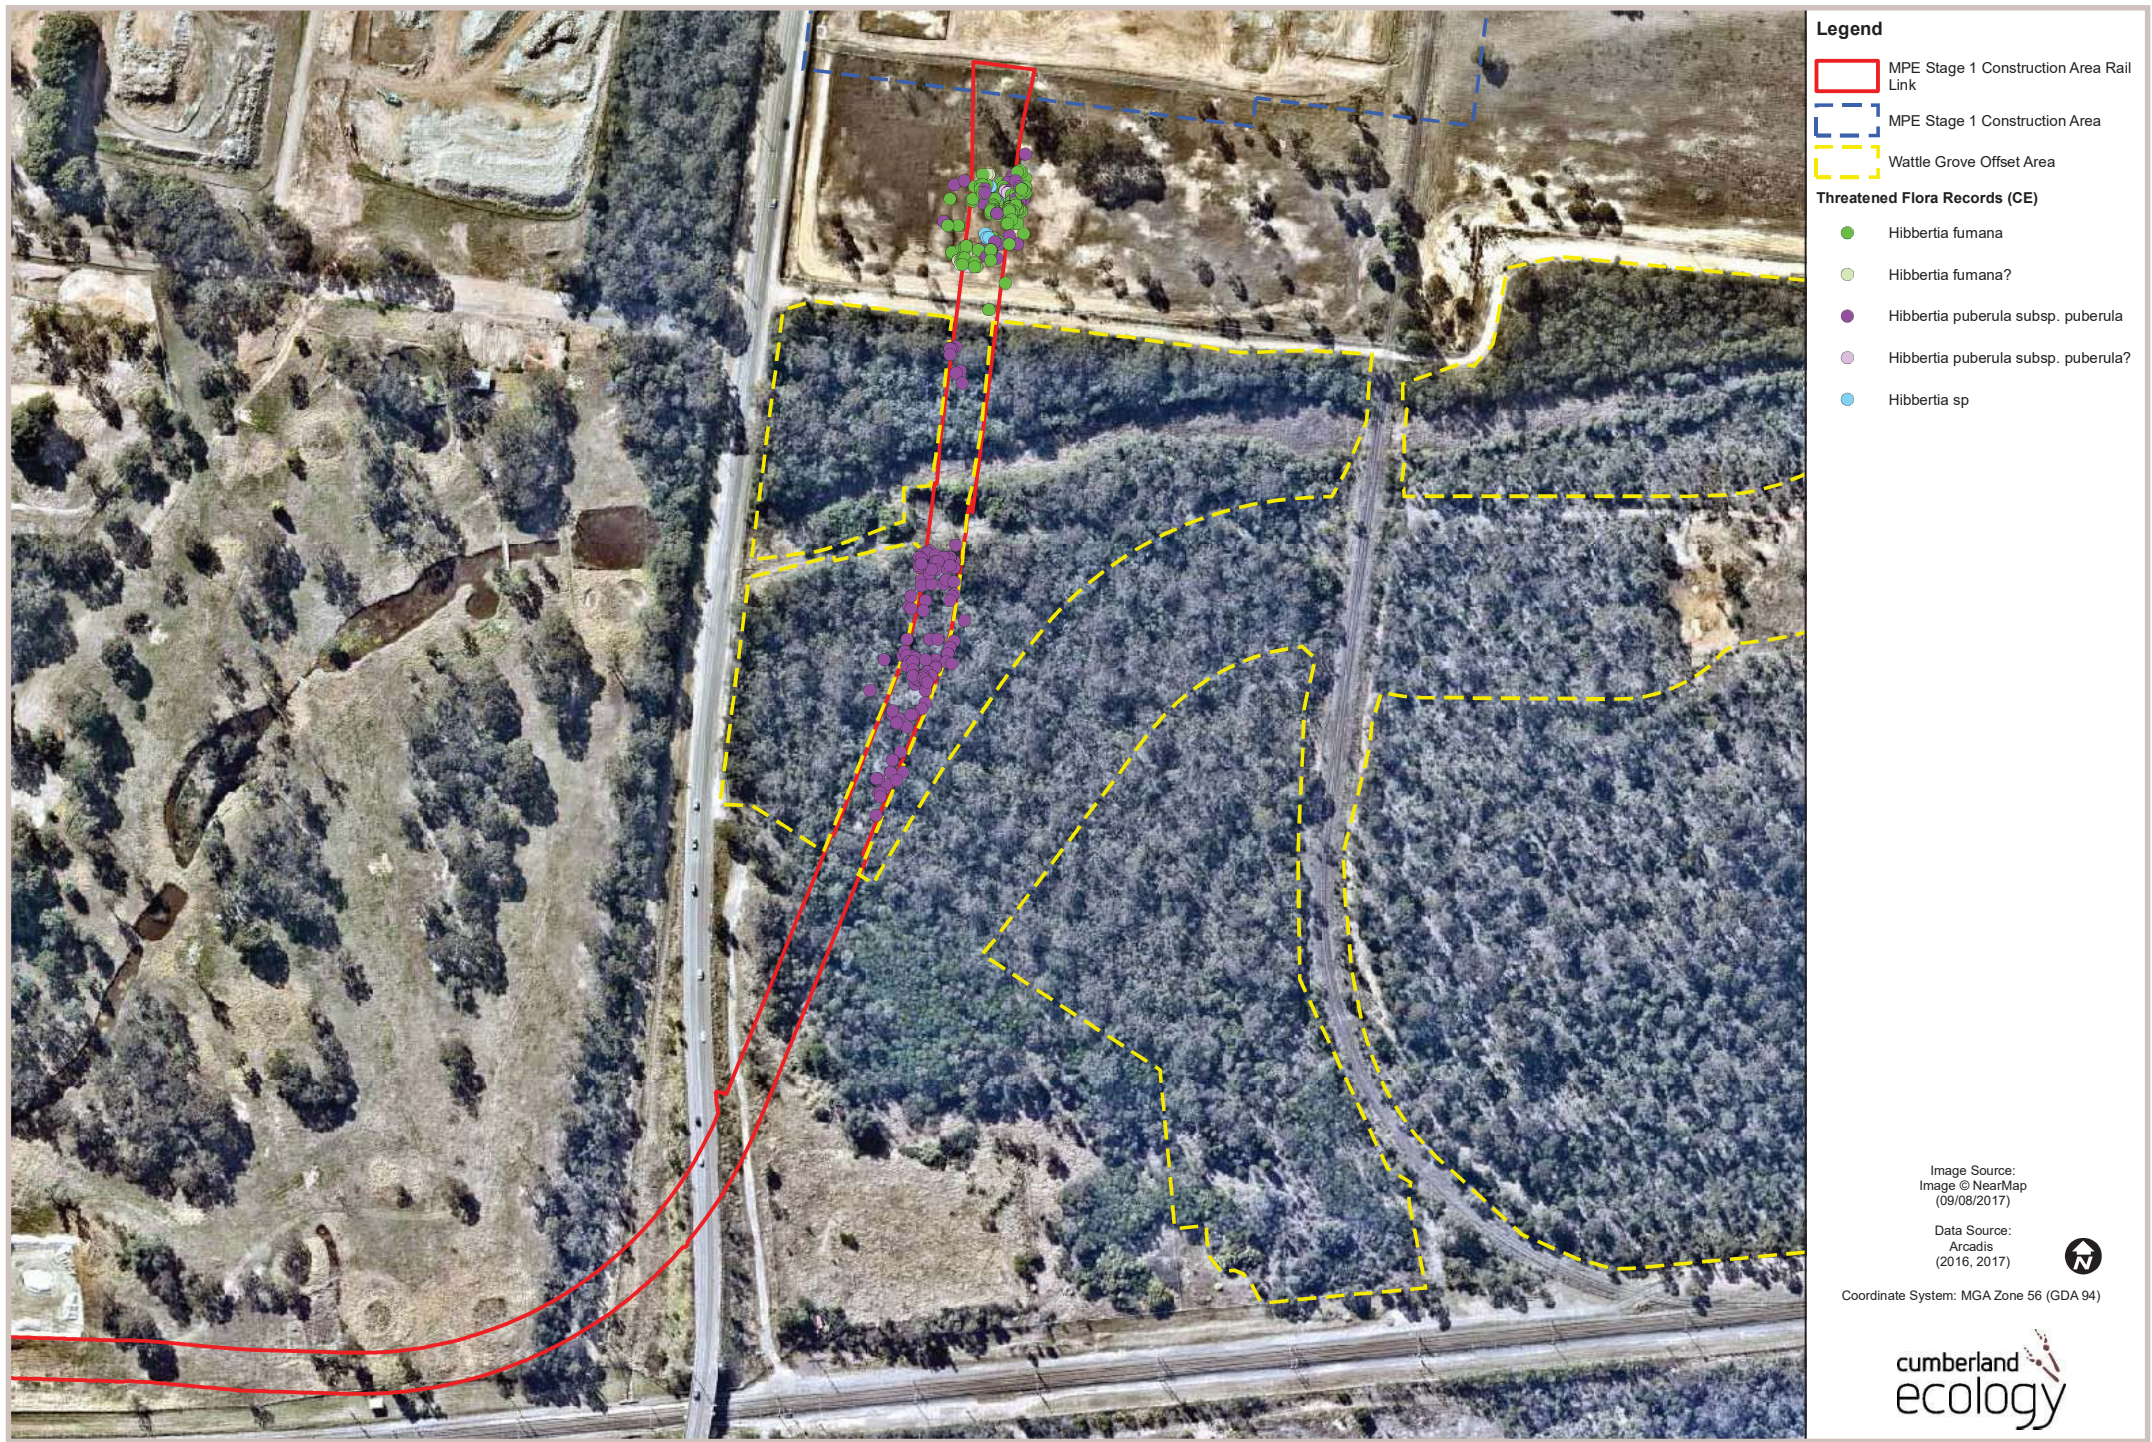
Figure 3. Hibbertia species within MPE Stage 1 Rail Link (Nov 2017 Pre-clearance records)

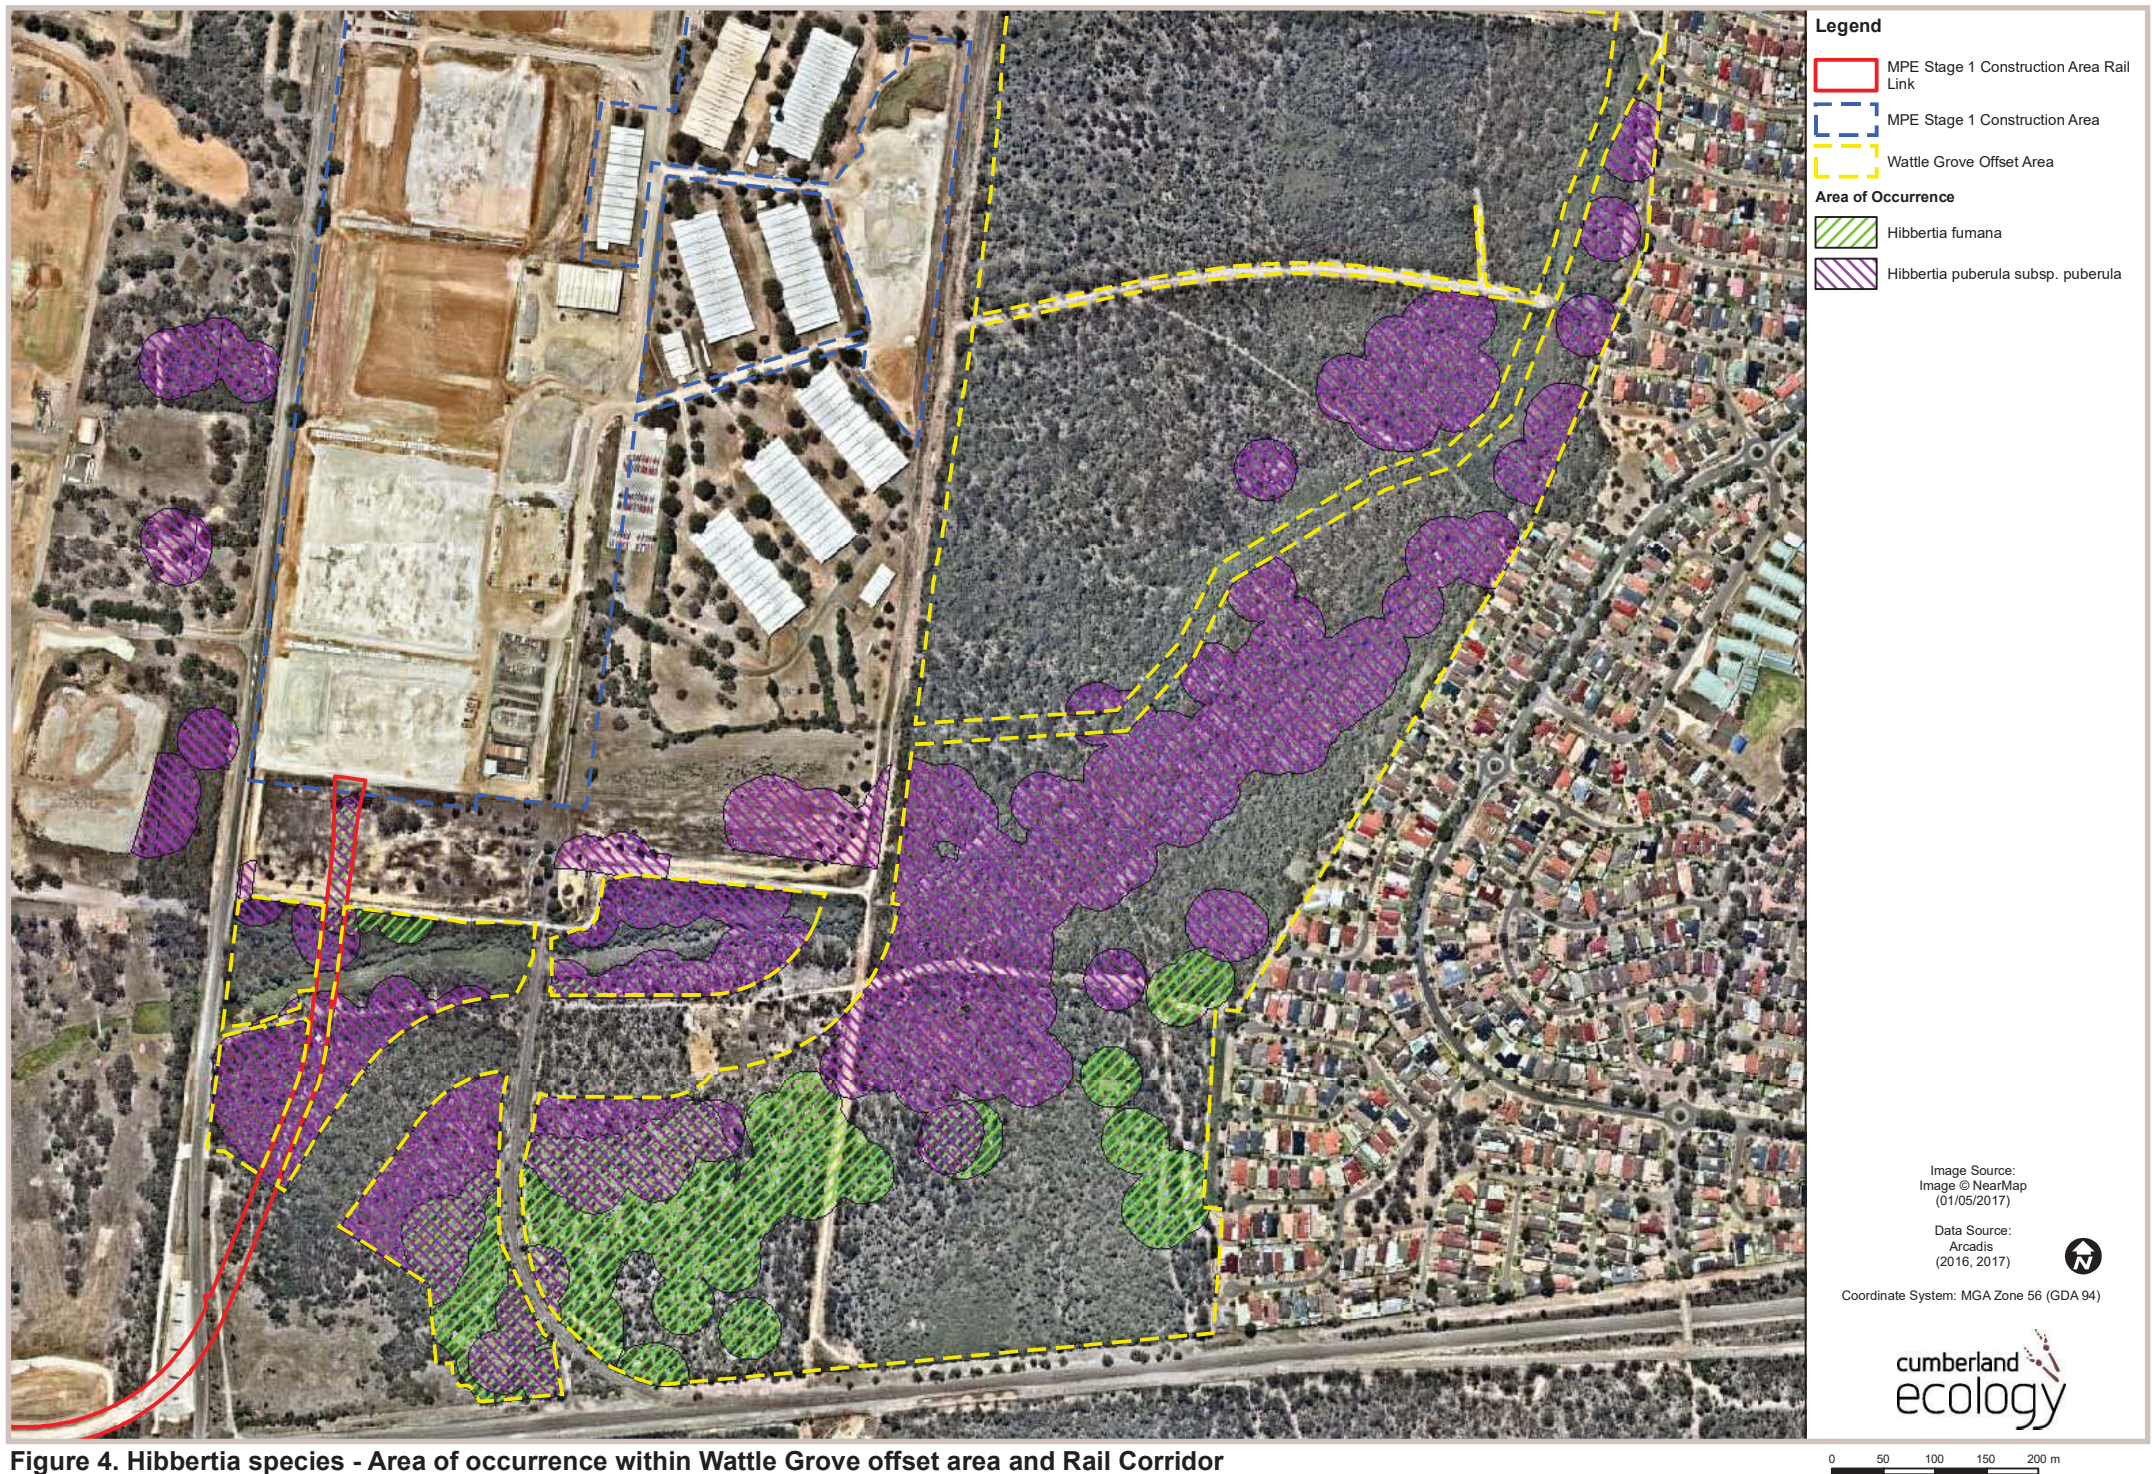
Figure 4. Hibbertia species - Area of occurrence within Wattle Grove offset area and Rail Corridor

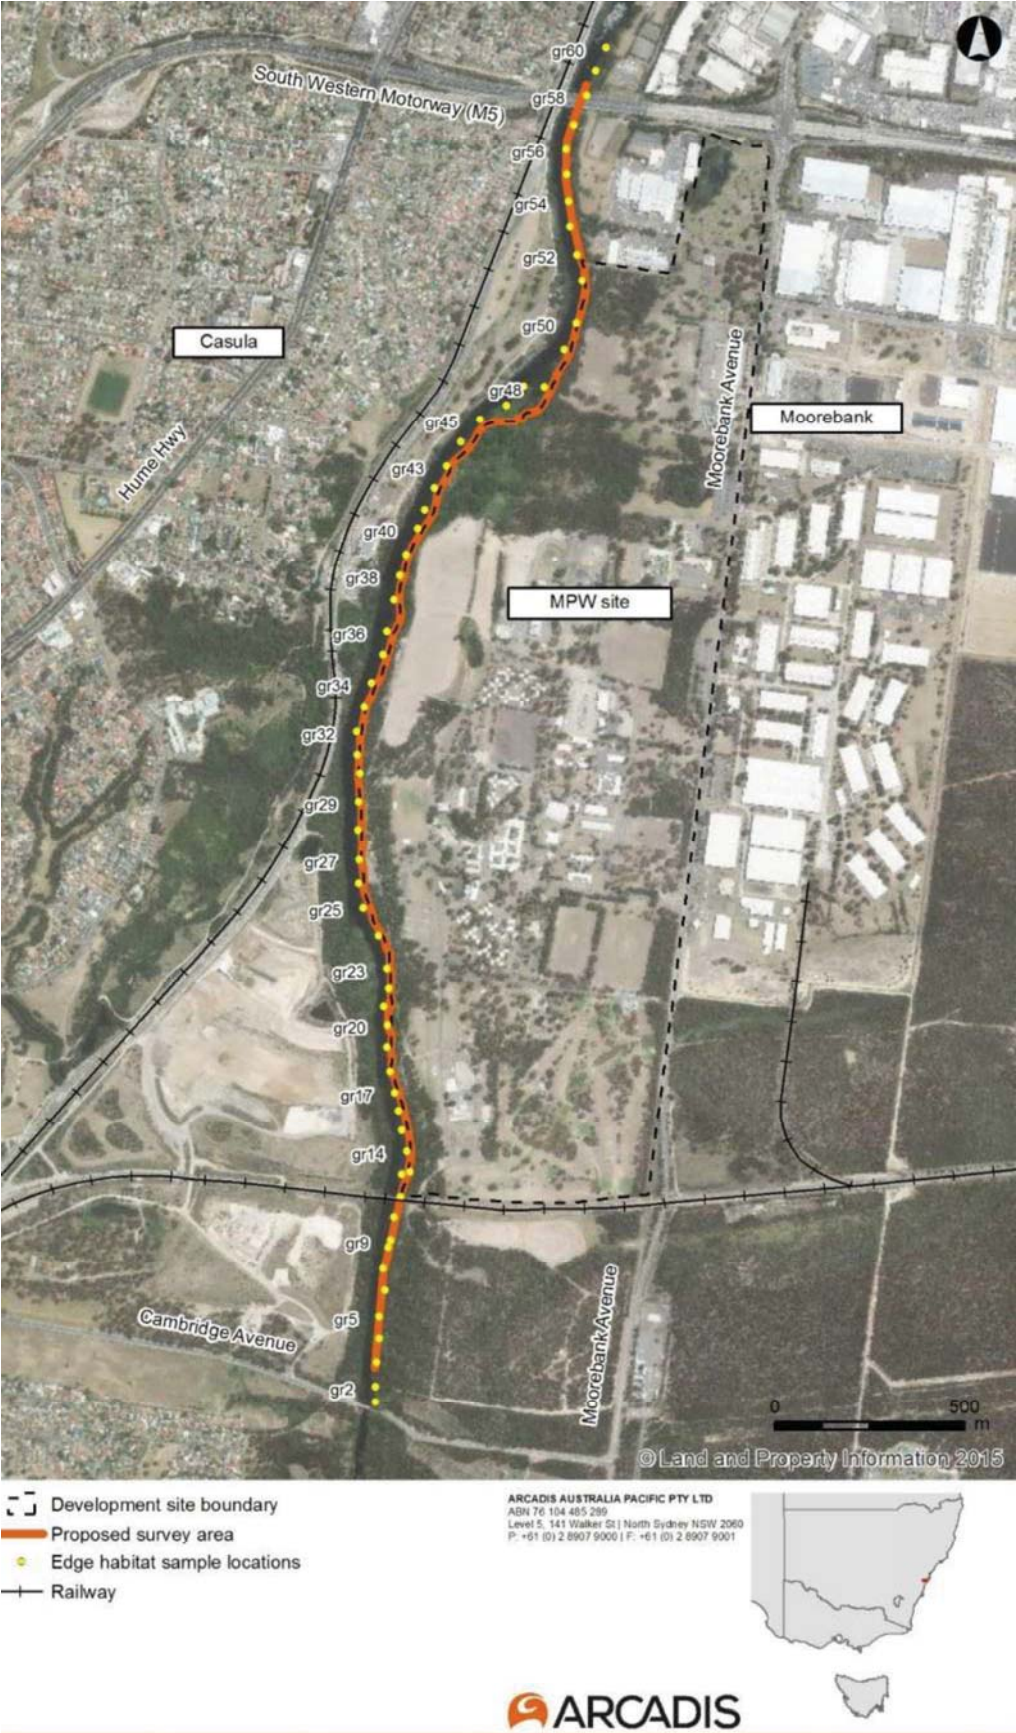
Figure 2 Survey area and actual habitat sample locations. The orange line indicates the survey area as proposed in the TDSSP.
