# Construction Flora and Fauna Management Plan

Moorebank Precinct East Stage 1 – RALP No. 1

<b>Project number:</b>	N01031
<b>Document number:</b>	EN-PLN-0017
<b>Revision date:</b>	21 May 2019
<b>Revision:</b>	07

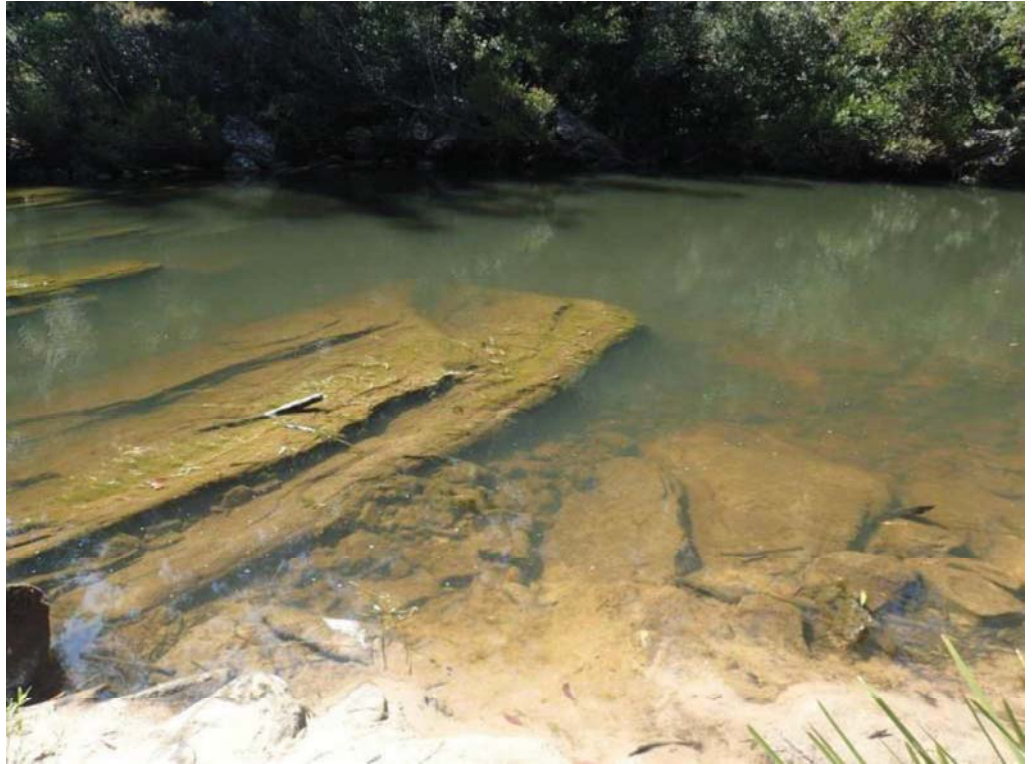
Freres Crossing itself is the site of the remains of a historic bridge on a road that once formed part of the 1917 highway connecting Campbelltown and Newcastle. A rock platform at this location forms somewhat of a natural weir at a narrowing of the river (Figure 14) which has resulted in a number of deep wide pools either side of it. These pools, which have a gravel/rock substrate and steep shaded sides, are characteristic of habitat for *A. leonardi* (Figure 15 and Figure 16).

*Figure 15 Deep pool with steep shaded sides and rocky bottom just upstream from Freres Crossing*

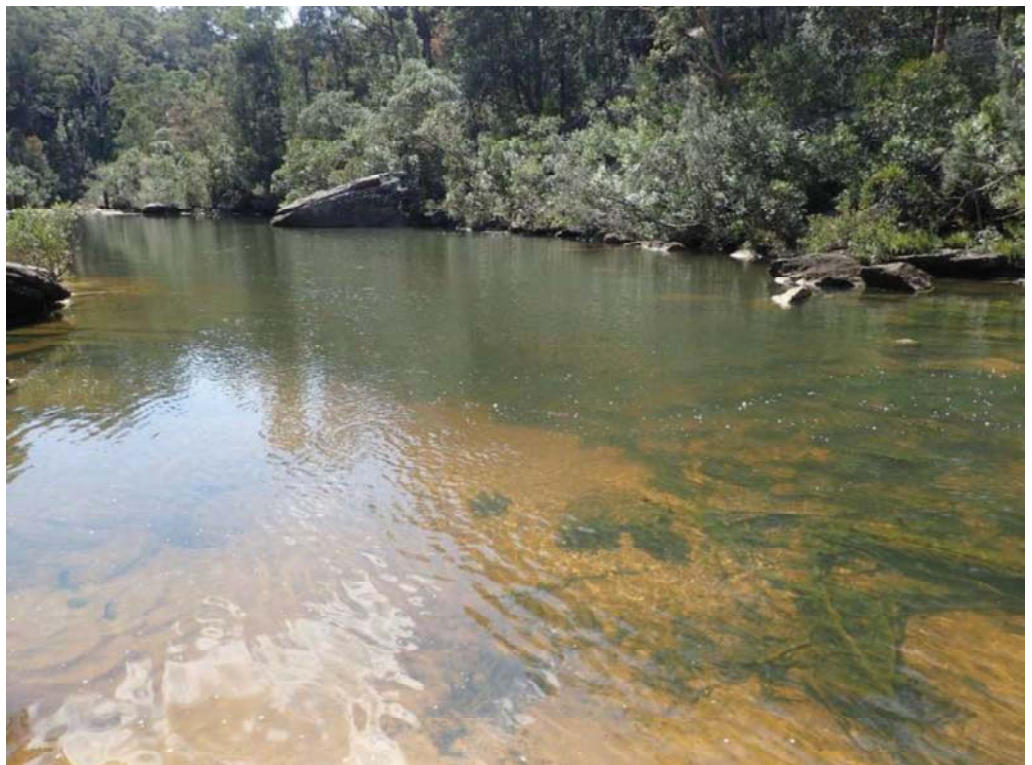
*Figure 16 Rocky bottom pool upstream from Freres Crossing*

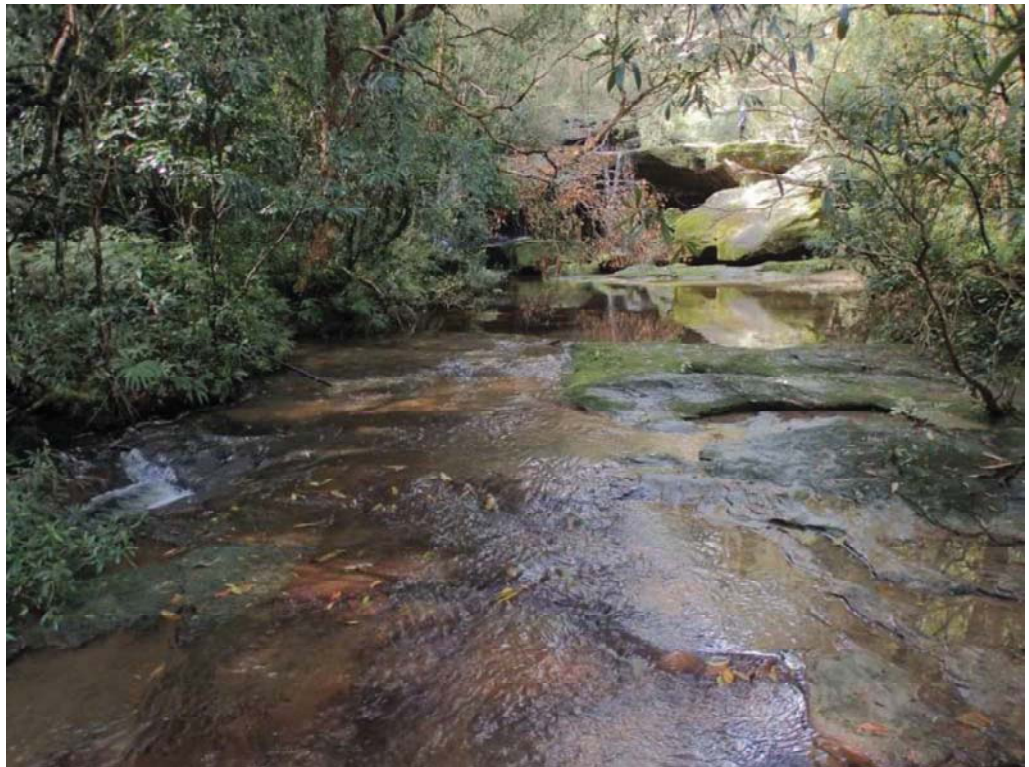
Downstream of Somersby Falls, Floods Creek is abundant in characteristic features of *A. adamsi* habitat. The stream is located below a closed canopy, with numerous riffle zones, mossy boulders and riparian vegetation. The substrate of the stream varied between bare sandstone, gravel and sand.

Figure 17 Floods Creek, habitat for *A. adamsi*. Narrow stream with shaded riffle zones, moss, riparian vegetation and sandy/gravel substrate.

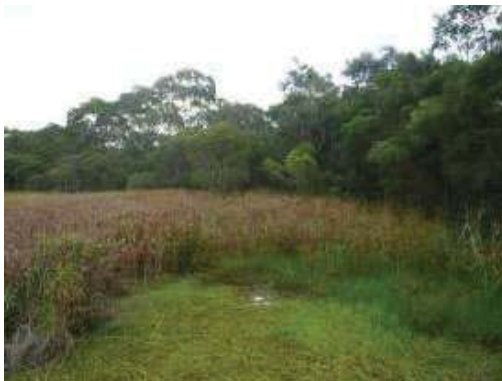
**Plate 4. Anzac Creek to west of existing rail spur, showing *Salvinia molesta* infestation in foreground and native sedges and rushes further upstream**
